## EROSION EXPOSURE ASSESSMENT—LEVELOCK

Report of Investigation 2021-3 Levelock

## LEVELOCK EROSION EXPOSURE ASSESSMENT

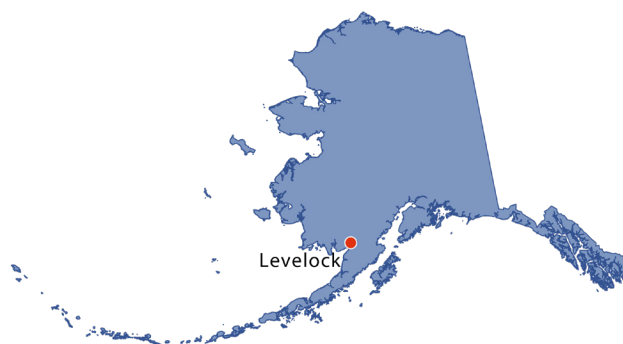
Levelock is located on the west side of the Kvichak River about 15 miles upstream from where the river exits into Kvichak Bay and northeast Bristol Bay. From 1951 to 2018, the river eroded between 1.0 and 3.3 feet per year at a relatively linear rate (Overbeck and others, 2020). Erosion is caused by riverine processes and fall storm surge (U.S. Army Corps of Engineers, 2007). Erosion is greatest near the boat launch on the south side of the community. Erosion rates have been near-stable

north of the dock. Other than the dock, there is no shoreline protection installed.

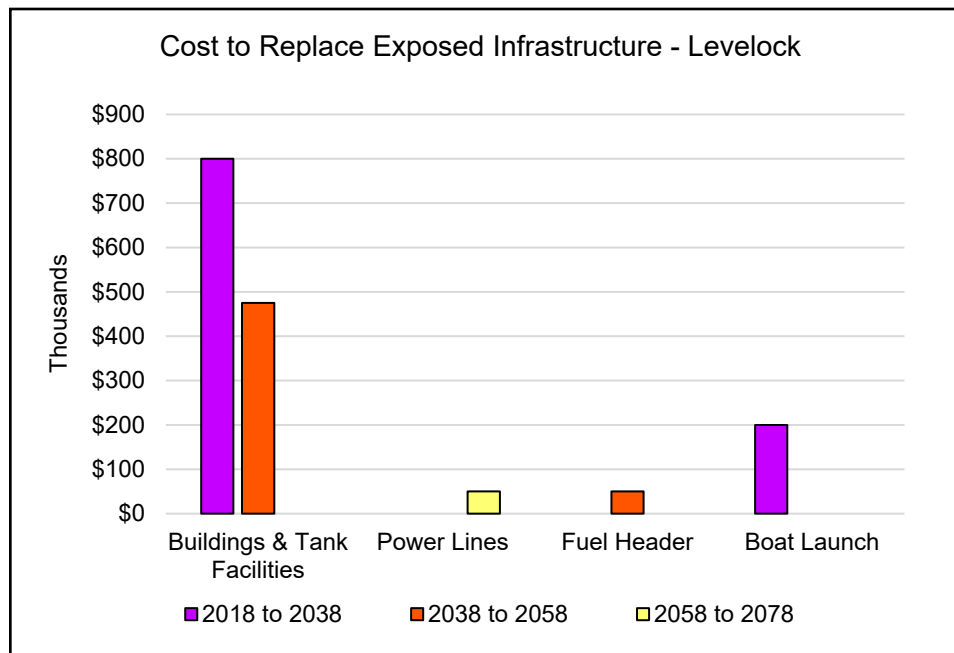
**Figure 1.** This figure summarizes the replacement cost of all infrastructure in the erosion forecast area. Twenty-year intervals are symbolized by color: purple represents the time interval 2018 to 2038, orange represents 2038 to 2058, and yellow represents 2058 to 2078. The bulk of costs are buildings, especially from 2018 to 2038.

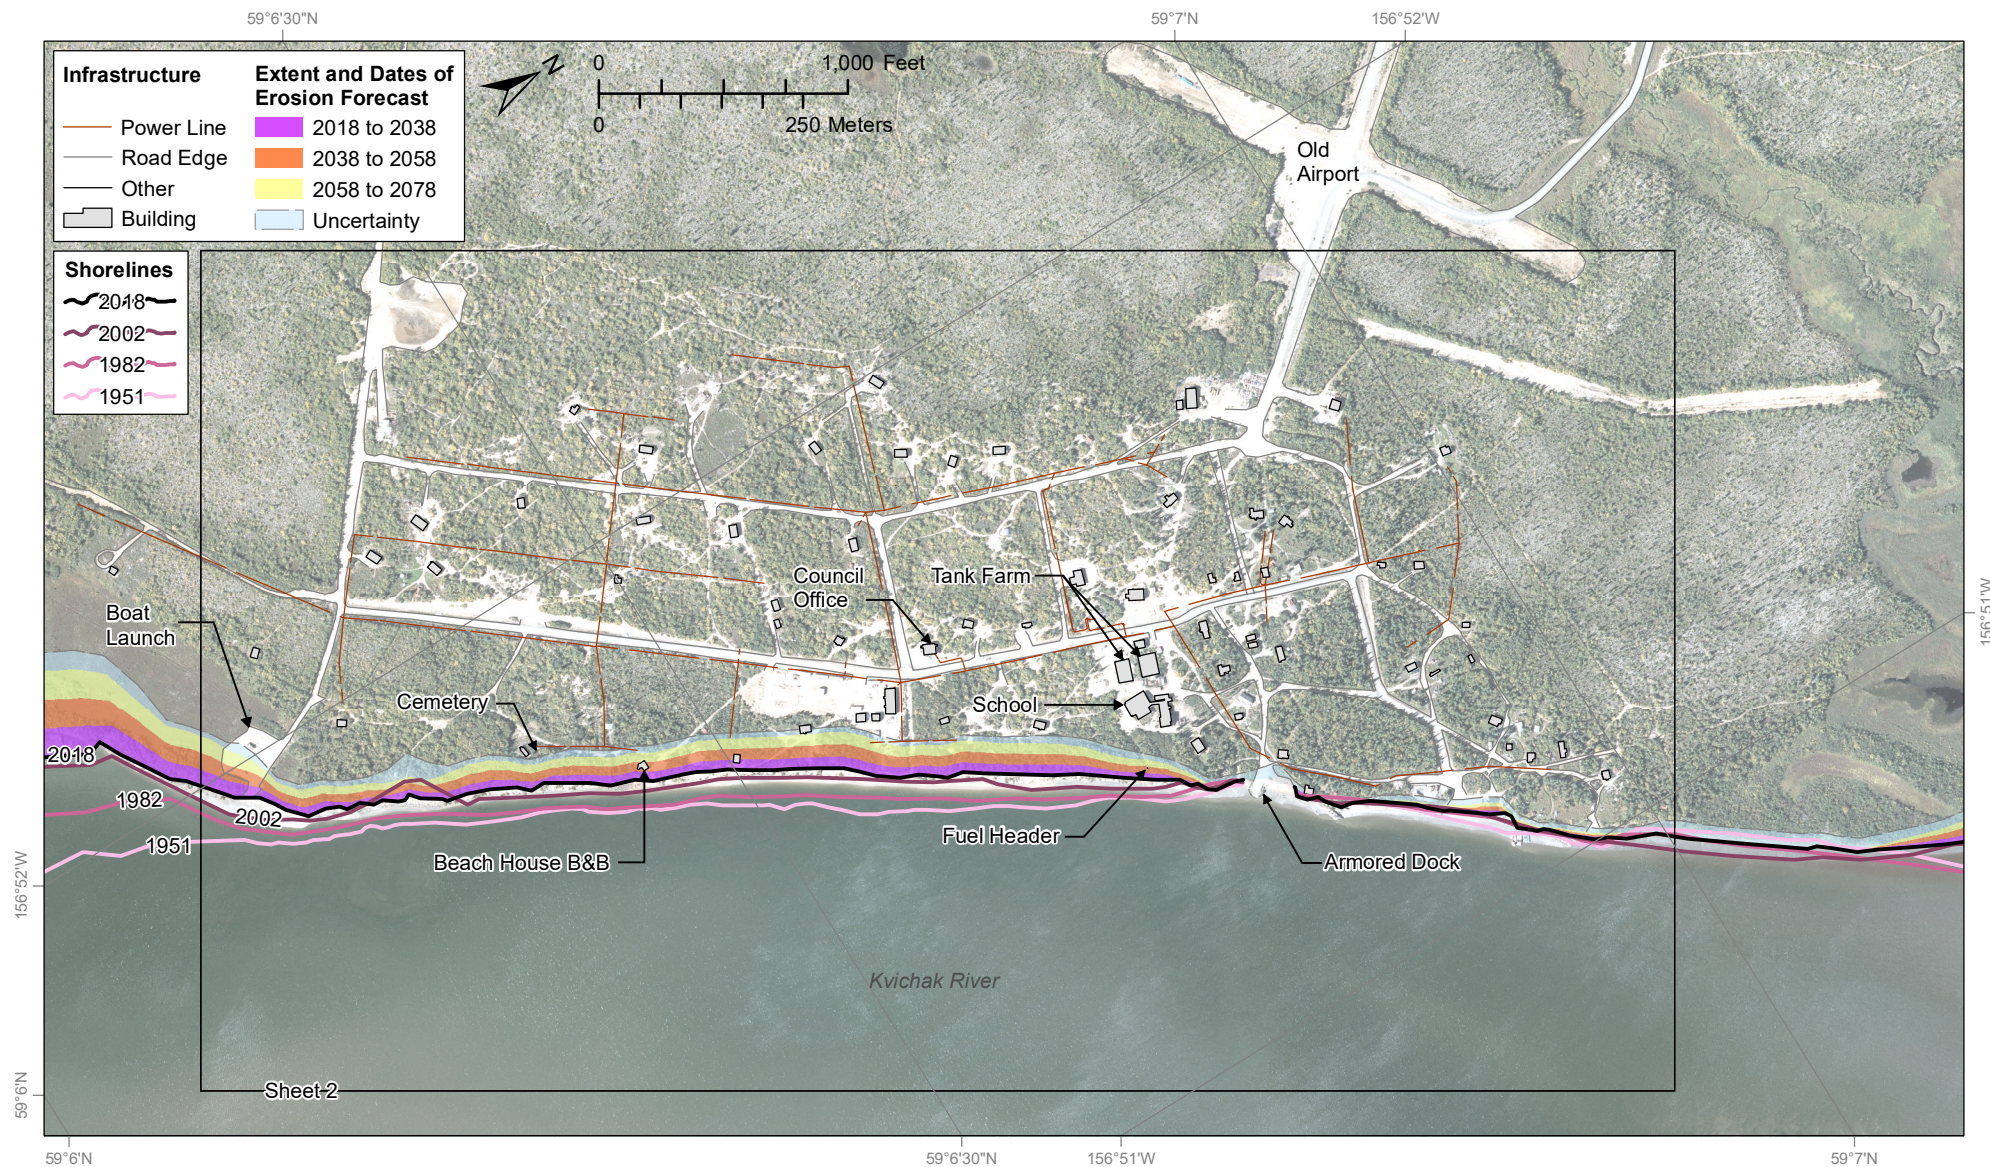
# Erosion Forecast Levelock, Alaska

Erosion and accretion of coasts and rivers result in shoreline change. These rates of shoreline change at Alaska communities are calculated from historical and modern shorelines (shorelines shown as lines in pinkscale and labeled by year). The long-term (1951 to 2018) shoreline change rate is used to forecast where erosion could impact community infrastructure. Erosion is forecast to reach the colored areas by specified time intervals: 2018 to 2038 (purple), 2038 to 2058 (orange), and 2058 to 2078 (yellow). The area of uncertainty of the 2078 shoreline at a 90 percent confidence interval is light blue. Areas that are not colored by time interval are not forecast to erode by 2078 based on the historical shoreline change rate. For more detailed information about the impacts to infrastructure from erosion at Levelock, refer to the Levelock erosion exposure assessment report.

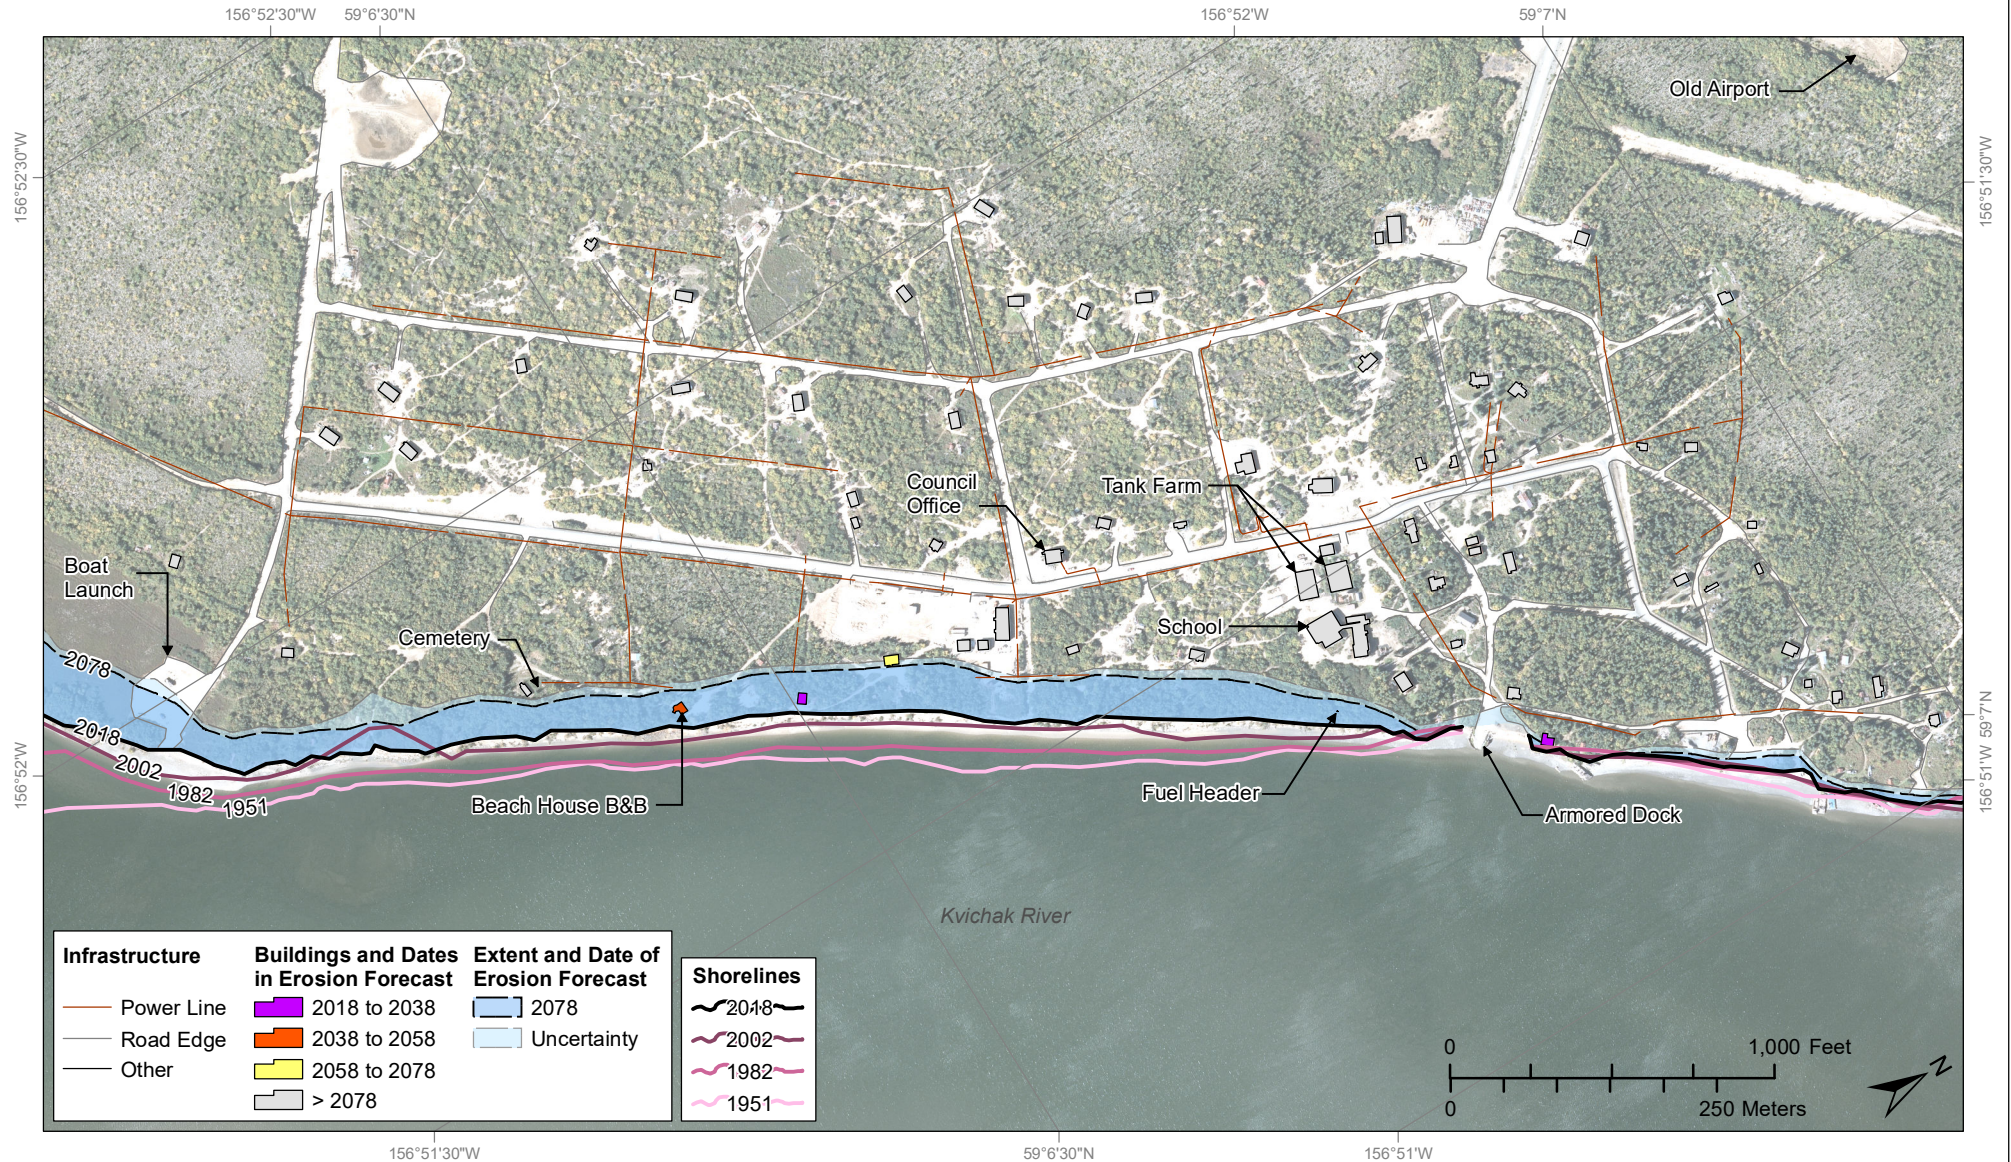
# Erosion Exposure Levelock, Alaska

Erosion and accretion of coasts and rivers result in shoreline change. These rates of shoreline change at Alaska communities are calculated from historical and modern shorelines (shorelines shown as lines in pink scale and labeled by year). The long-term (1951 to 2018) shoreline change rate is used to forecast where erosion could impact community infrastructure. Erosion is forecast to year 2078 (dark blue) with a 90 percent confidence interval area of uncertainty (light blue). Buildings forecast to be impacted by erosion are colored by the range of years when the impact is forecast to occur: 2018 to 2038 (purple), 2038 to 2058 (orange), 2058 to 2078 (yellow), and no impacts expected by 2078 (gray). For more detailed information about the impacts to infrastructure from erosion at Levelock, refer to the Levelock erosion exposure assessment report.
