## EROSION EXPOSURE ASSESSMENT—PORT HEIDEN

Report of Investigation 2021-3 Port Heiden

State of Alaska  
Department of Natural Resources  
Division of Geological & Geophysical Surveys

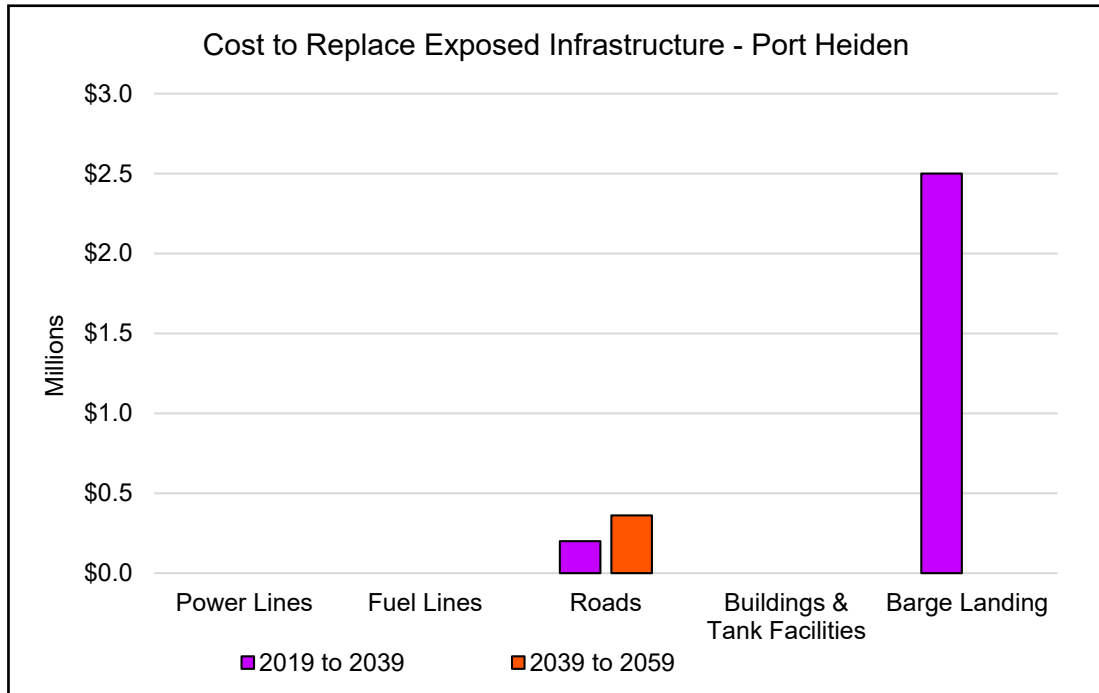
distance from the nearest barge landing pole and the 2039 shoreline to 500 ft. There is one abandoned structure exposed to erosion by 2059. It is possible that erosion will slow if sediment continues to fill in near the barge landing, which also complicates barge operations and navigability. For this reason, we list the barge landing as requiring replacement by 2039. The forecast shows continued undermining of the road to Meshik, which is used for subsistence activities, with up to 1,400 ft exposed in 40 years. The forecast shows erosion of small trail systems on the coast northwest of the community but does not reach the main road to Reindeer Creek by 2059. The total replacement cost of infrastructure exposed to erosion is \$3.06 million ( $\pm$  \$0.92 million) by 2059

(table 2; fig. 1). We do not estimate erosion exposure for water lines because the data are not readily available and no visible water line infrastructure exists in the forecast area. There may be abandoned underground pipes and septic systems that do not have a replacement cost but will require cleanup when they are uncovered by erosion.

**Figure 1.** This figure shows the replacement cost of utilities, transportation infrastructure, and buildings and tank facilities that are forecast to erode per 20-year interval. Twenty-year intervals are symbolized by color: purple represents the time interval 2019 to 2039 and orange represents 2039 to 2059. The bulk of costs are the barge landing in the first 20 years (purple).

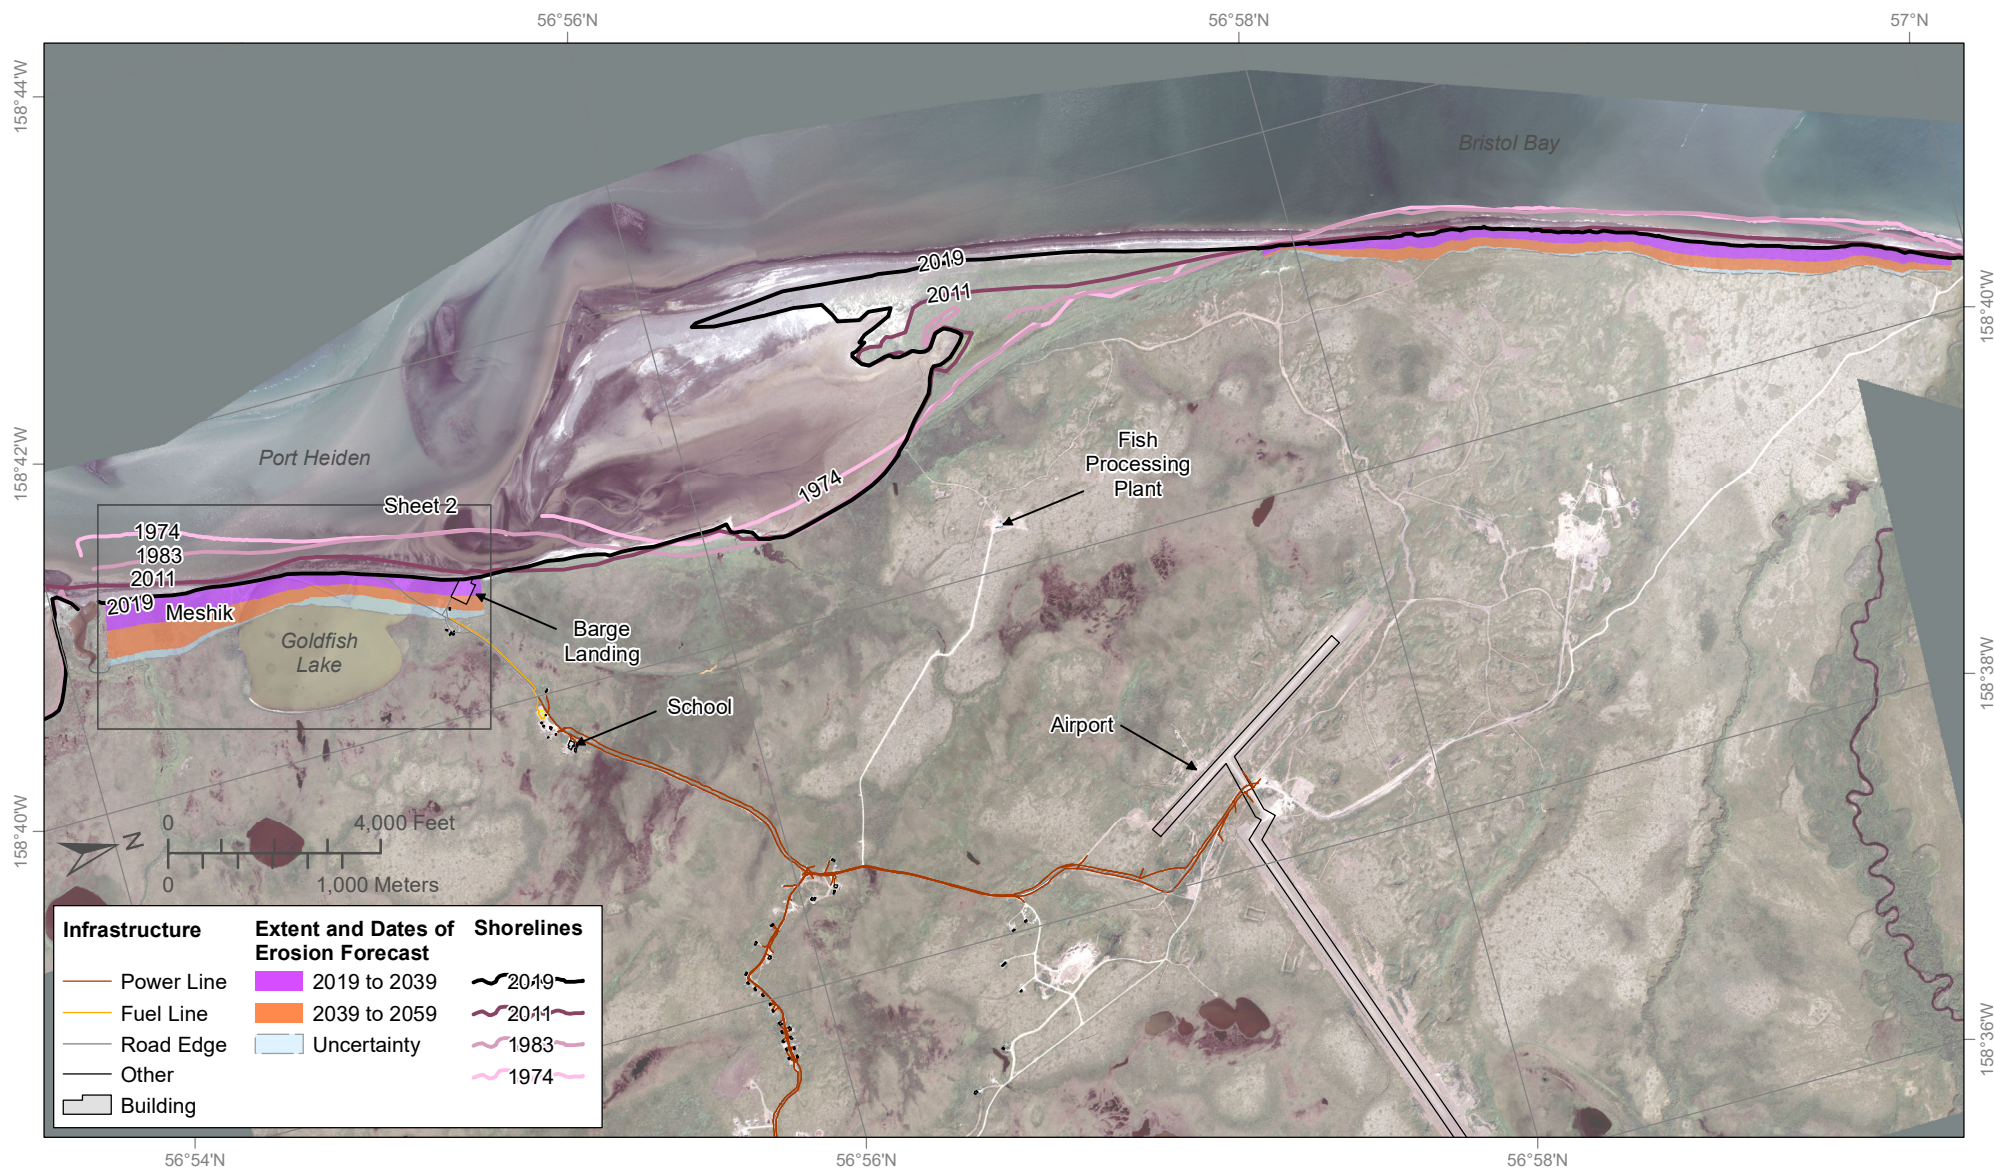
# Erosion Forecast Port Heiden, Alaska

2014). From 1957 to 2013, the average erosion rate was between stable and 23 feet per year. The complete disappearance and redistribution of sediments from the barrier Chistiakof Island exposed the Meshik shoreline to waves, increasing erosion rates after 1974 (Kinsman and Gould, 2014). Because of the marked increase in erosion rates, we only use the 1974 to 2019 shorelines (45 years) to forecast 40 years of erosion.

We forecast erosion 40 years from the most recent shoreline (2019) at 20-year intervals to identify the exposure of infrastructure to erosion. The erosion forecast shows nearly the entire footprint of Meshik is exposed to erosion through 2039. There is no visible infrastructure within most of the erosion forecast area by 2059. The greatest impact to current infrastructure in Port Heiden is the barge landing site. Most of the barge landing area is forecast to erode by 2039 (table 1), expanding out the

Erosion and accretion of coasts and rivers result in shoreline change. These rates of shoreline change at Alaska communities are calculated from historical and modern shorelines (shorelines shown as lines in pink scale and labeled by year). The long-term (1974 to 2019) shoreline change rate is used to forecast where erosion could impact community infrastructure. Erosion is forecast to reach the colored areas by specified time intervals: 2019 to 2039 (purple) and 2039 to 2059 (orange). The area of uncertainty of the 2059 shoreline at a 90 percent confidence interval is light blue. Areas that are not colored by time interval are not forecast to erode by 2059 based on the historical shoreline change rate. For more detailed information about the impacts to infrastructure from erosion at Port Heiden, refer to the Port Heiden erosion exposure assessment report.

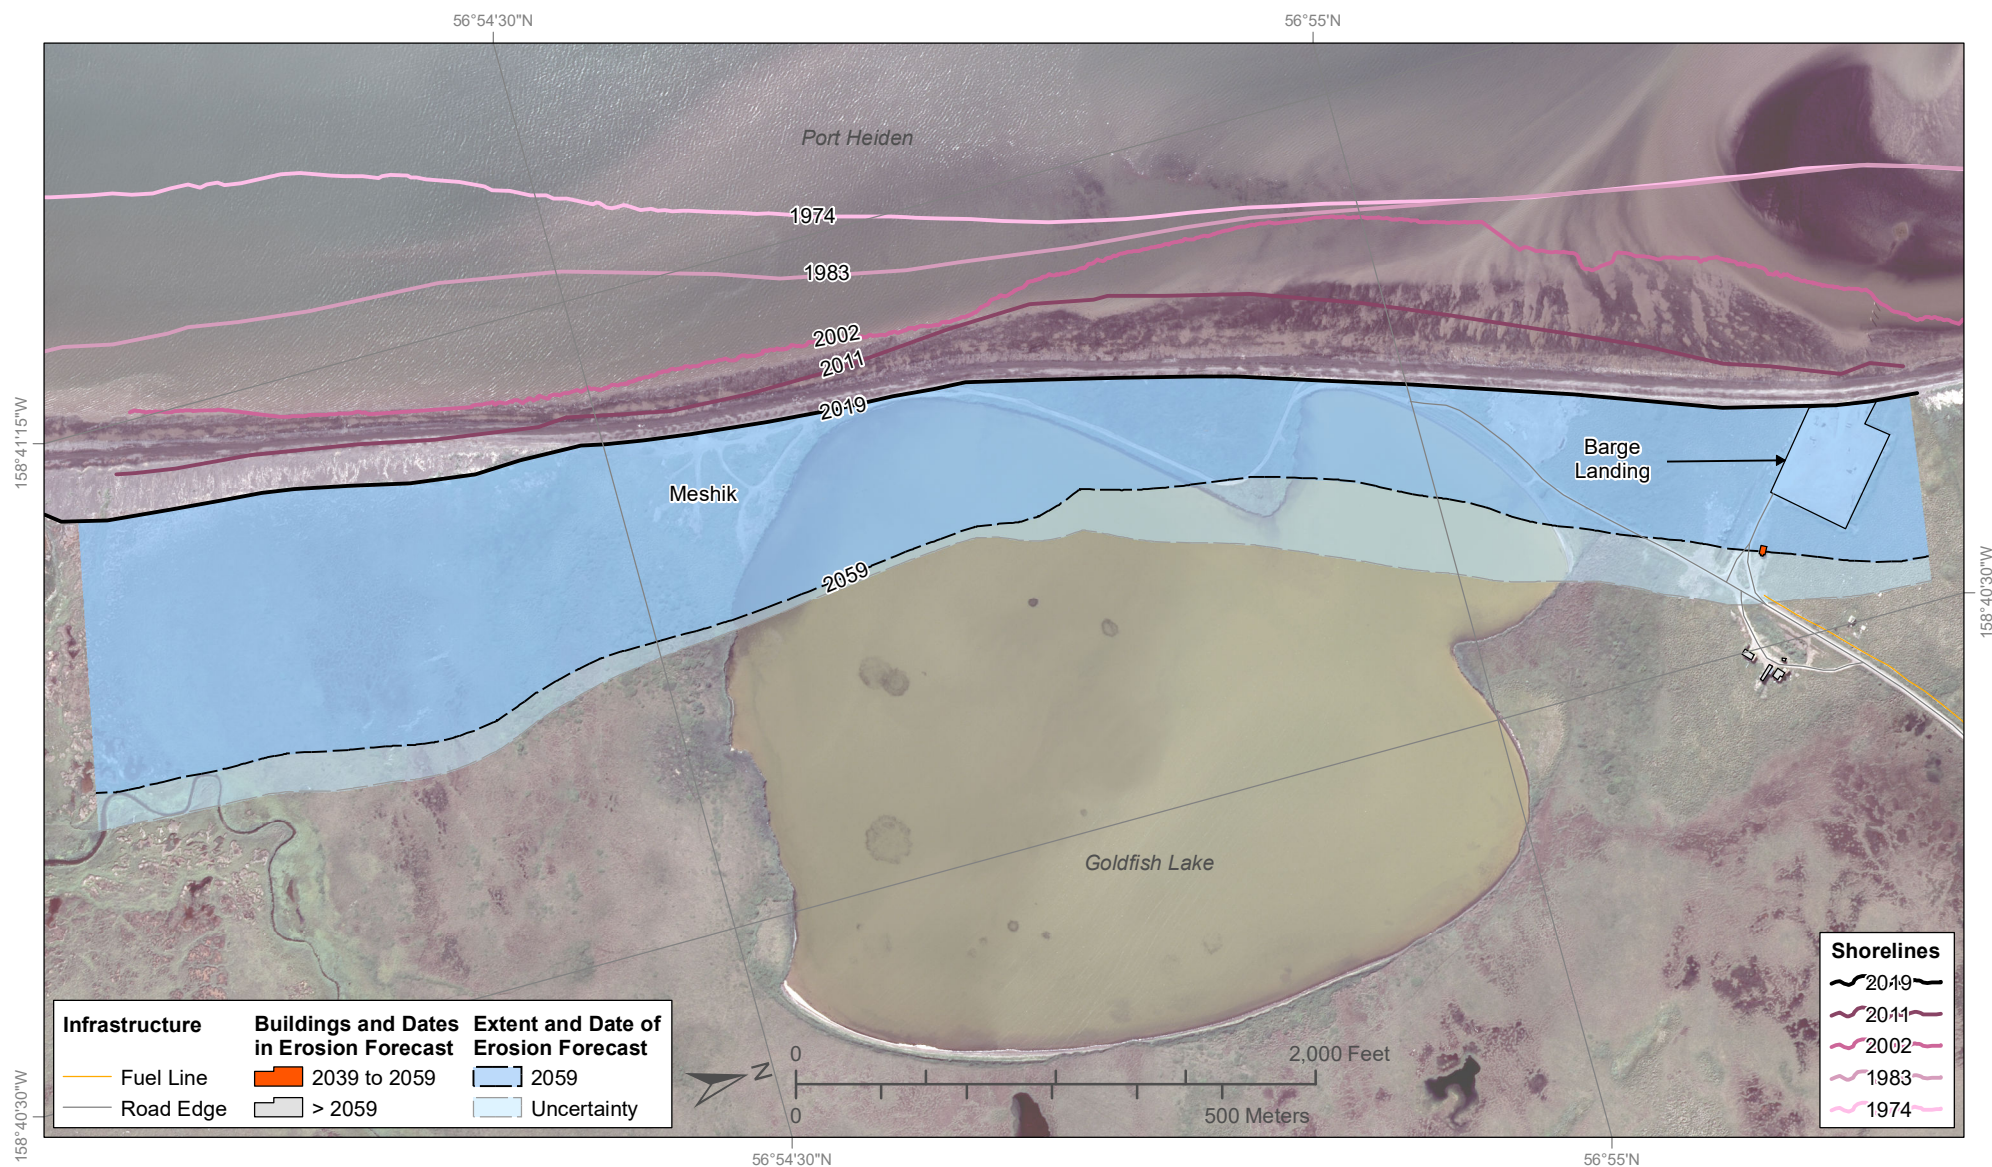
# Erosion Exposure Port Heiden, Alaska

Erosion and accretion of coasts and rivers result in shoreline change. These rates of shoreline change at Alaska communities are calculated from historical and modern shorelines (shorelines shown as lines in pinkscale and labeled by year). The long-term (1974 to 2019) shoreline change rate is used to forecast where erosion could impact community infrastructure. Erosion is forecast to year 2059 (dark blue) with a 90 percent confidence interval area of uncertainty (light blue). Buildings in the erosion forecast area are colored by impact year range: 2019 to 2039 (purple), 2039 to 2059 (orange), and no impacts expected by 2059 (gray). For more detailed information about the impacts to infrastructure from erosion at Port Heiden, refer to the Port Heiden erosion exposure assessment report.
