## **COMPREHENSIVE ENERGY AUDIT**

**SOUTH NAKNEK WATER TREATMENT PLANT, SANITATION SYSTEM,  
TRIBAL OFFICE, CLINIC, AND COMMUNITY CENTER**

**South Naknek, Alaska**

August 2, 2011

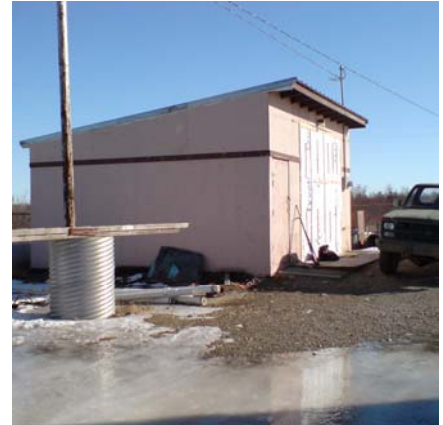
### **2.5.2 Mechanical Building**

The maintenance facility receives minimal use under normal operations. Currently the structure is being used as heated storage for an adjacent construction project.

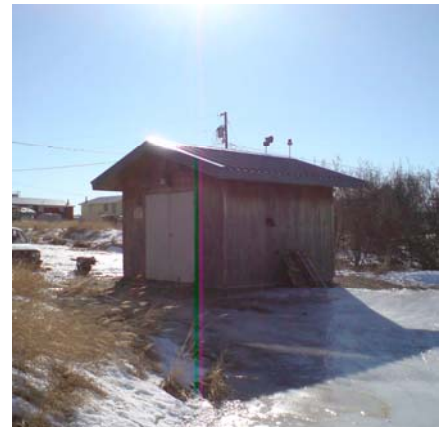
### **2.6.1 Lift Station 1**

Lift station 1 consists of a single divided facility. As sewage flows into the wet well the level rises to a point where one of two suction lift Hydromatic 30MP pumps are activated. The sewage is then pumped via a force main to the transition manhole. The building is heated electrically, which along with pump use is responsible for the majority of the buildings energy costs.

The heater in the wet wells of the lift stations are unnecessary and could be turned off year round. This would result in a savings of 35% of the total heating costs in the lift stations or \$1008/year.

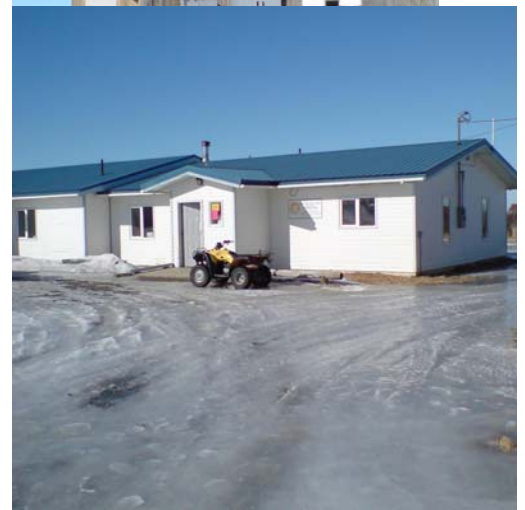
## **2.7 Health Clinic**

The health clinic is used on a semi-regular basis. The village does not maintain a year long health aide, but instead will host an aide at the clinic for two week periods once a month. The aide lives in the clinic, and operates the clinic four days a week, six hours a day. The building is 2x6 construction with above grade floors, and roughly 800 square feet.

The clinic is a fairly tight building as well, with good windows and relatively little leakage. The crawl space should be better insulated, as this is the primary air leak location in the building. Additionally all electrical outlets should be back insulated to prevent heat losses. Assume an hour to install electric outlet insulation, half an hour for board stock insulation for the crawl space.

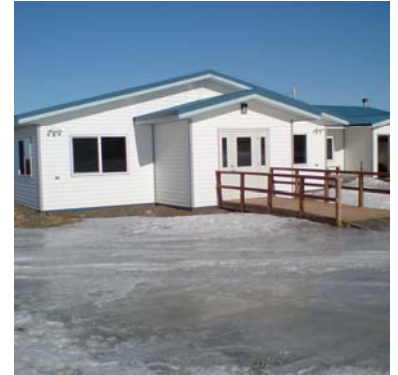
## **2.8 Community Center**

The community center is used primarily by one tribal employee who works 5 days a week 8 hours a day in the summer, and 2 or 3 days week in the winter 8 hours a day. She maintains a small office. Three other offices in the building are being renovated for eventual usage as the tribal office. The main floor area of the building is used only three times a year on average, for funerals and community events. The square footage of the main facility is roughly 2450 square feet, and the back offices under construction add an additional 450 square feet. The building is 2x6 construction with above grade floors and has been added onto recently.

In terms of electrical load, the primary contributors in this building are appliances such as computers, coffee pots, and radios, as well as fluorescent lighting fixtures.

While the community center is fairly new, there are a few areas to prevent leakage. As in all the buildings in South Naknek, exterior electrical outlets were drafty and causing a noticeable leakage of heat. It takes about 5 minutes and .50/outlet to put in outlet insulation. There are about 12 exterior outlets in the community center.

Some spray in foam for around the doors would reduce the slight draftiness caused by separation in the door framing. There also appears to be a serious cold spot in the ceiling where the new community center expansion connects to the old community center.

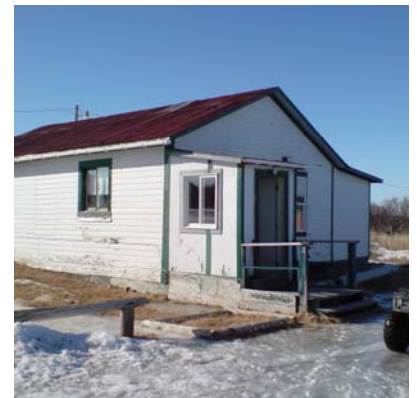
## **2.9 Tribal Office**

The Tribal Office in its current state is very rarely used. The active office has been relocated to a remote site in Wasilla, Alaska. The operators for the treatment plant and sewage system use the building sparingly, less than an hour per day. Offices are being renovated in the community center to accommodate a move from the current Tribal Office. The building is 2x6 construction with above grade floors.

After performing a blower door test, the tribal office was revealed to be a very leaky building. Many of the windows have significant air leakages, including one window that cannot close all the way in the back office. Given that the building is soon to be unused, it would not be sensible to replace the poor quality windows, but instead to seal them with 2 inch board stock insulation when not used for ventilation or lighting.

Additionally, the crawl space was fairly leaky in the front office, and should be covered to prevent leakage. Filling electrical outlets to prevent further leakage, as in all buildings is recommended to prevent heat losses. Assume \$20/window materials, 30 minutes/window labor, and an hour each for insulation of outlets and the attic door. Assume 10% heat loss savings from windows, 1% from electrical outlets, and 5% from the attic door.

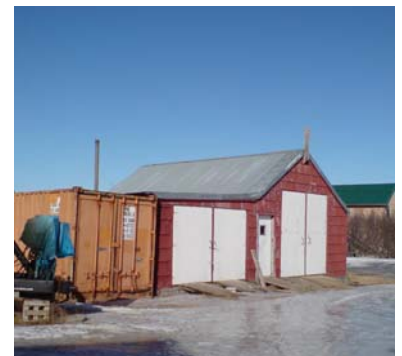
### **Old Fire Station**

The Old Fire Station is in use only as a cold storage facility. All fire safety vehicles are now located at the Borough fire station. The building uses no electricity or fuel electrical and service is not connected to the facility.

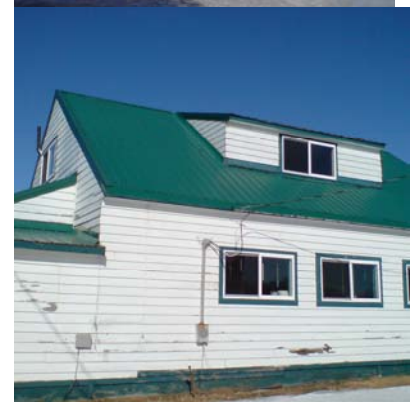
### **Youth Center**

The youth center is utilized only as a cold storage facility. The building uses no electricity or fuel. The Electrical connection has been disconnected at the meter base.

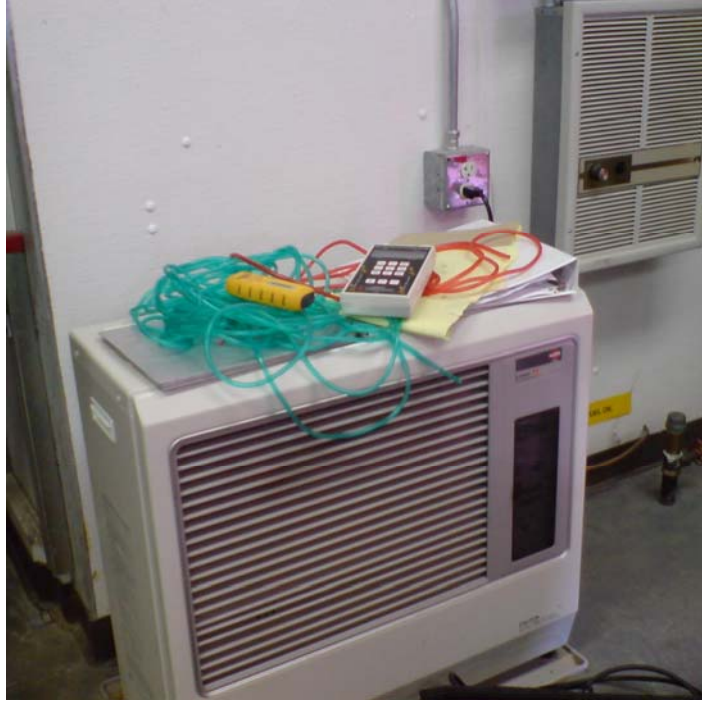
The toyo stove in the water treatment plant has broken igniter and is in need of replacement. The water treatment plant has been running the electric wall heater visible in the picture to the right. This change in usage is equivalent to 700 kilowatt hours a month, or \$210/month (winter time). This cost of running the Toyo stove at the same rate would be about 30 gallons a month of fuel oil, or \$165/month. Replacing the igniter would cost about \$100.

| Measure | Cost | Savings/year | Simple Payback |
|---|---|---|---|
| Replace Igniter | \$100 | \$250 | 5 months |

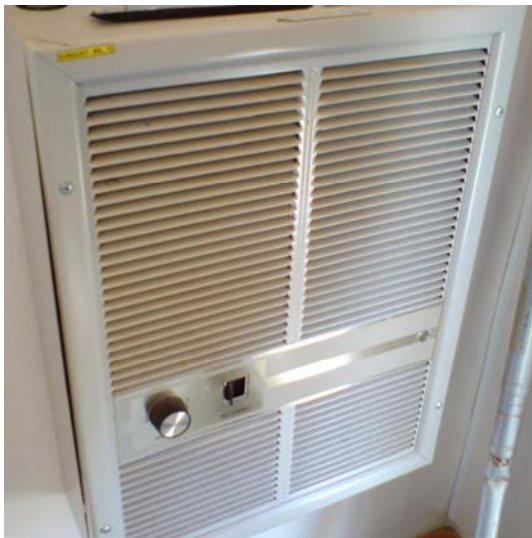
(main heater)

Additionally the minimum temperature setting in the rest of the lift station is unknown, and though it is set to heat to “minimum”, this temperature is really only necessary to keep the lines from freezing. When the temperature is not expected to be below freezing for more than half the day for long stretches (early fall, and late spring) the entire heating unit could be turned off, saving 5% of the heating for a savings of \$144/year.

| Measure | Cost | Savings/year | Simple Payback |
|---|---|---|---|
| Turn off Heaters when unnecessary | 0 | \$1,152 | Immediate |

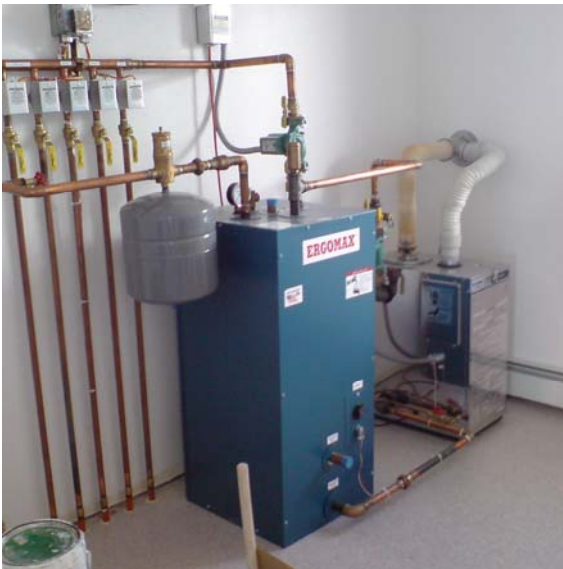
**(Community Center Piping)**

Heat generated by the boiler system is being dissipated through the primary and secondary heating loop piping. Insulation should be installed on this piping to ensure that heat is being retained for its intended use. Losses from piping will increase the temperature in the boiler room, and increase the energy that must be supplied to the system. In the clinic this piping is being exposed to cold outside air causing additional heating losses. Insulating this piping could save \$50 per year in fuel costs.

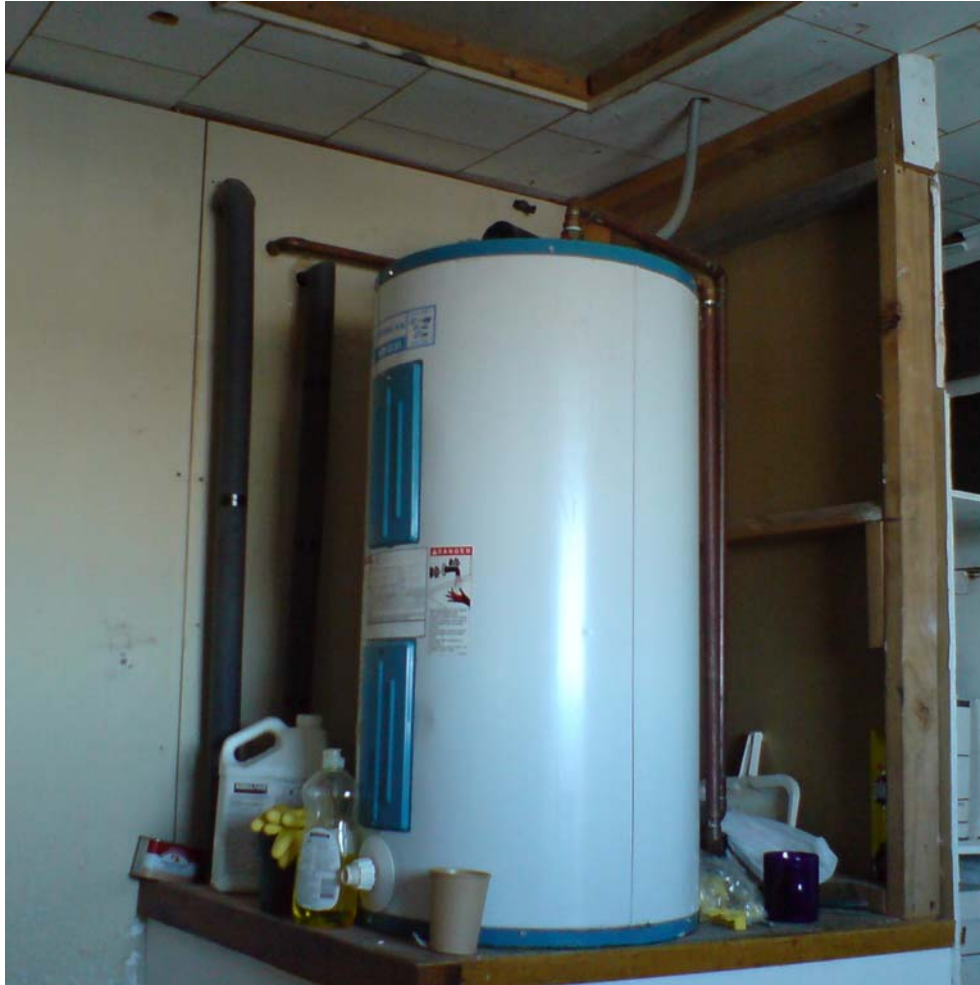
Currently the electric water heater in the tribal office is heating water that is never used. The bathroom in the tribal office is rarely needed, as the building is essentially unused. By flipping the breaker to the off position for the electric water heater, this needless electricity usage of 800 kwh could be eliminated.

| Measure | Cost | Savings/year | Simple Payback |
|---|---|---|---|
| Turn off electric hot water heater | 0 | \$560 | Immediate |

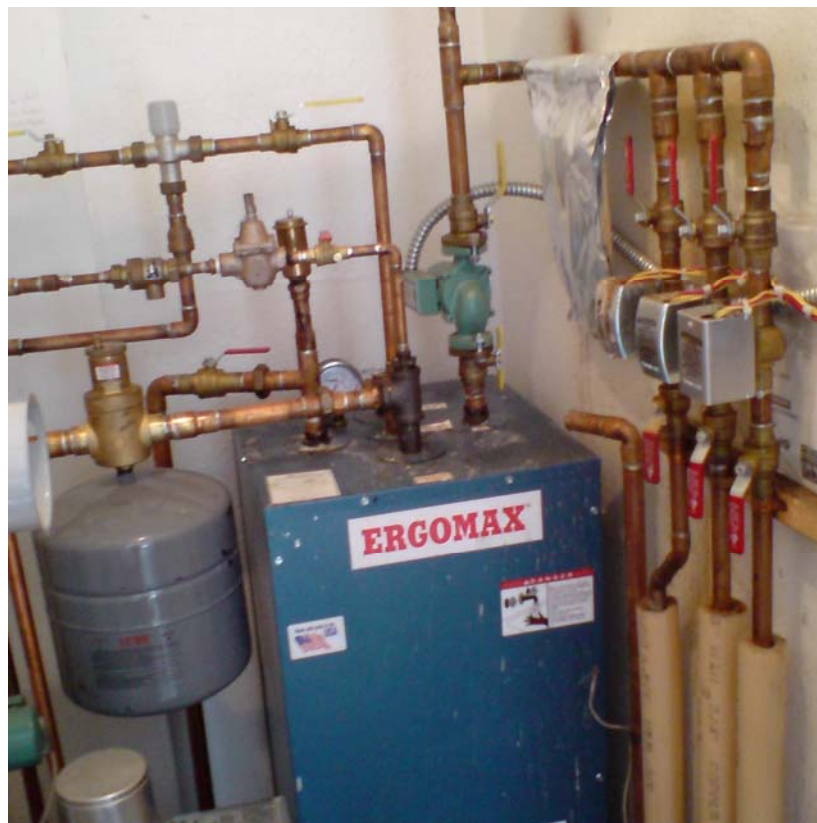
Currently the hot water heater in the clinic is ready for use at all times, despite the clinic's intermittent use. While this hot water heater also serves the community center, there is very little need for hot water in the community center with only two bathrooms without showers.

Turning down the hot water heater when the clinic is not in operation, which is roughly half the year would result in significant fuel usage savings.

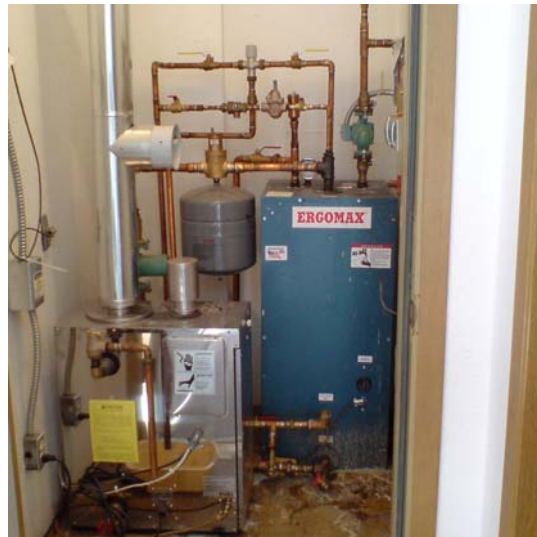
Currently the health clinic boiler utilizes inside combustion air and natural draft ventilation. This set-up requires that excessive outside air be available in the boiler room to ensure adequate combustion air, and prevent hazardous carbon dioxide levels. This also increases the energy losses from the exposed heating hydronic components and domestic hot water systems. Additionally heat from inside the facility will be lost to the boiler room through leaks and conduction.

Changing the existing boiler to a sealed combustion unit similar to the unit in the community center will reduce heating loads in the clinic, and save almost \$400 in fuel costs per year.

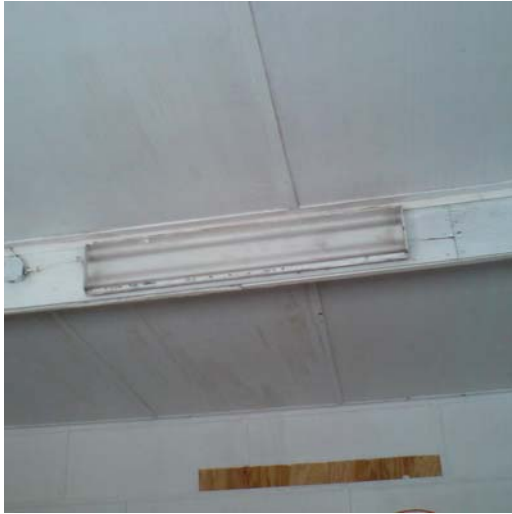
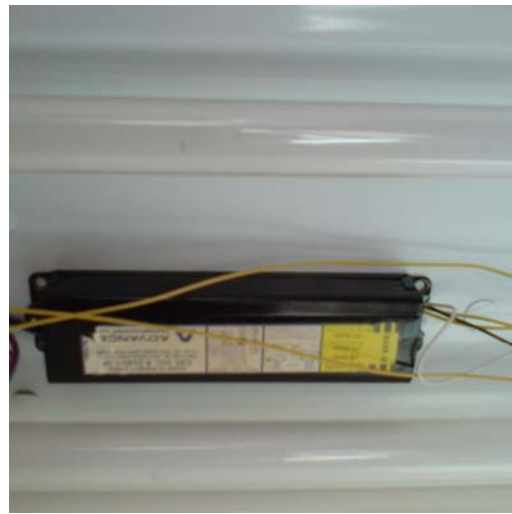
Replace T8s, T12s with LEDs

Given the relatively low usage rates of the buildings, and the high cost of LED lighting alternatives, it is not cost effective to install new fluorescent lighting in any of the other buildings. Replacing all 40W T12 fluorescent bulbs and 32W T8 bulbs with the appropriate LED bulb would cost around \$5,826 to install, with an annual savings of \$272.65 at the PCE rate of electricity of \$0.30, for a payback period of just over 21 years.

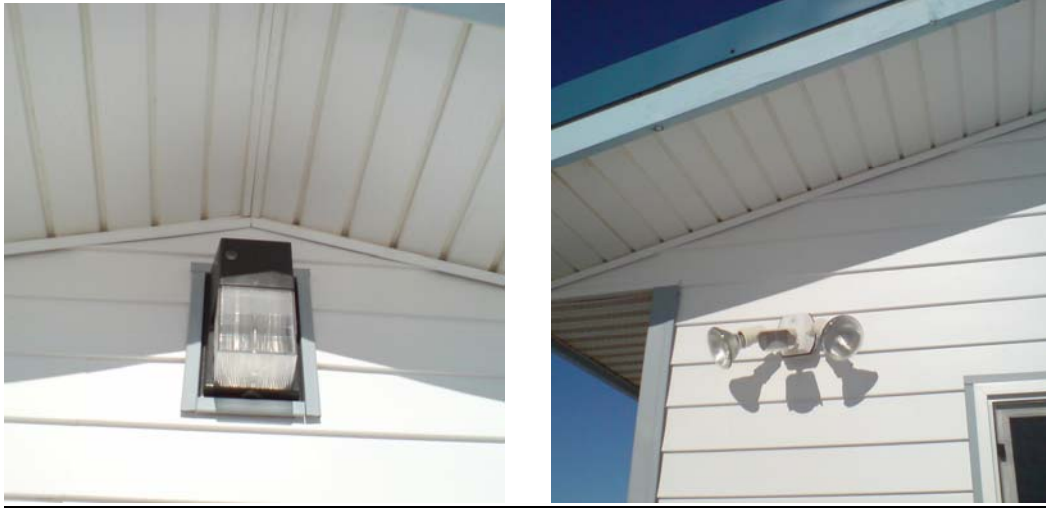
Replacing exterior lighting with highly efficient LED wall packs which perform well in cold temperatures would represent a significant savings. There are 4 wall packs worth replacing, three on the clinic/community center, and one on the water plant. There are 3 sets of motion sensor emergency lights to replace on the community center/tribal building.

| Measure | Cost | Savings/year | Simple Payback |
|---|---|---|---|
| Replace 4Wall Packs with LEDs | \$500 | \$236 | 2.12 years |
