## SHORELINE CHANGE AT ALASKA COASTAL COMMUNITIES

Report of Investigation 2020-10

State of Alaska  
Department of Natural Resources  
Division of Geological & Geophysical Surveys

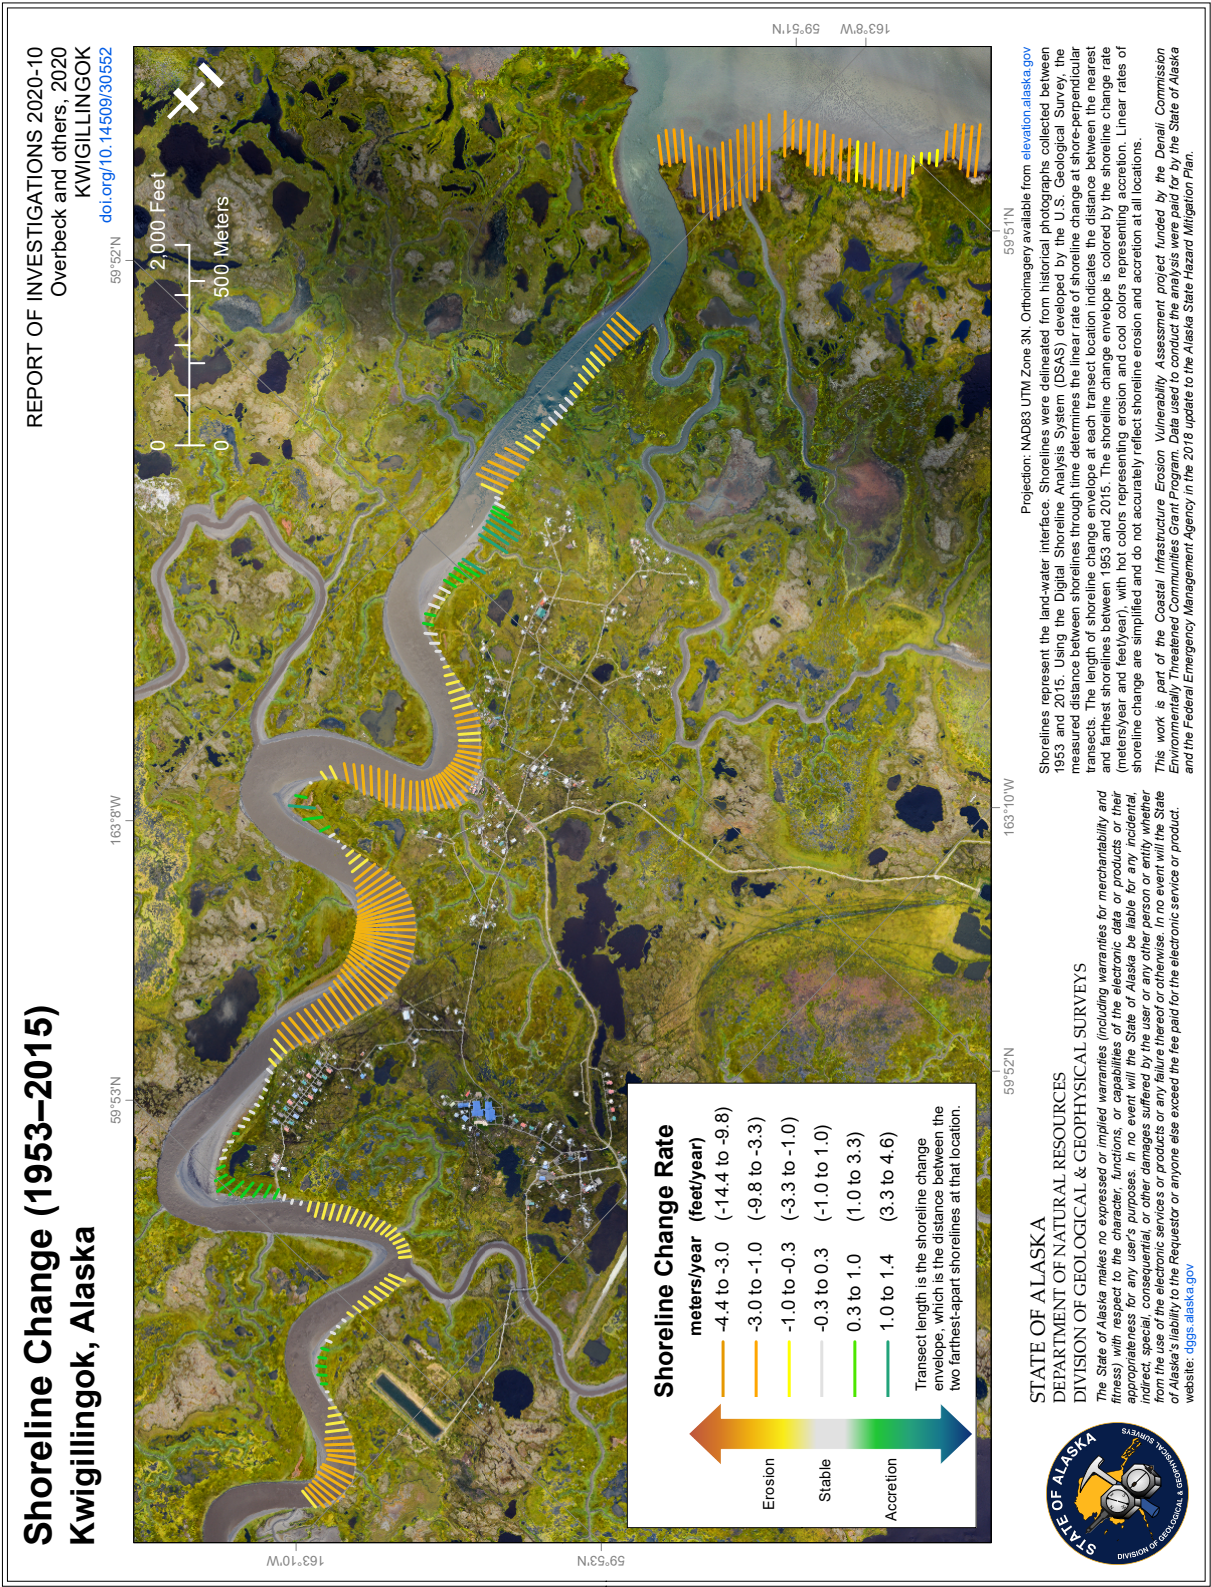
**Figure 3.** Example of map sheet for Kwigillingok, Alaska. Map shows the distance between the two farthest-apart shorelines at cross-shore transects (shoreline change envelope). The shoreline change envelope is colored by the rate of shoreline change, with hot colors indicating erosion and cool colors indicating accretion. Both erosion and accretion along the Kwigillingok River and erosion of coastline along Kuskokwim Bay (right side of map) have occurred (or were measured) in Kwigillingok

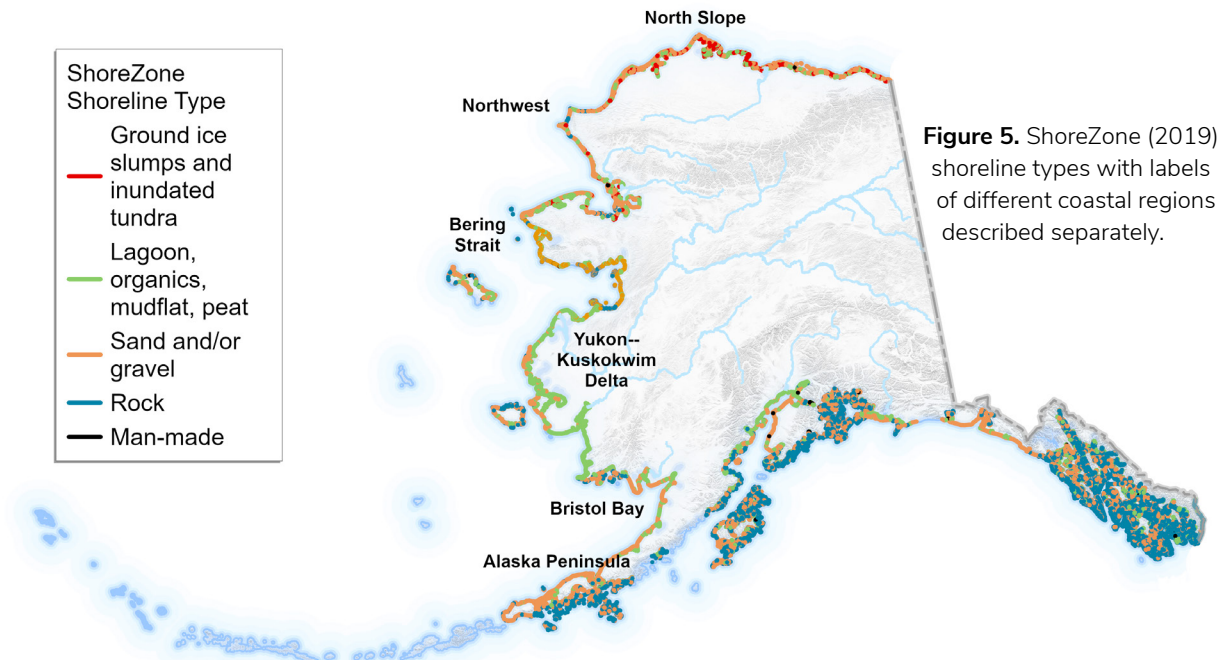
coastal processes and management strategies have also varied. Different zones of the coastline have been grouped here (i.e., North Slope, Northwest Arctic, Bering Strait, Yukon–Kuskokwim Delta, Bristol Bay, and Alaska Peninsula; fig. 5) to aid in discussion regarding the drivers of shoreline change and the responses to erosion.

Across all regions of Alaska the coastline is very diverse, ranging from micro- to macrotidal, and including areas of inundated tundra, vegetated peat, mudflats, lagoons fronted by barrier islands, inlets, bays, beaches, bluffs, or cliffs (Gorokhovich and Leiserowiz, 2012; ShoreZone, 2019; fig. 5). The coast is composed of materials ranging from ice to organics to mud, sand, gravel, or rock (ShoreZone, 2019; fig. 5). Northern and western Alaska are on passive tectonic margins, which results in low relief compared to the mountainous active margins of the Aleutians, southcentral Alaska, and southeast Alaska. Northern and western Alaska also experience relative sea level stability compared to sea level decline or rise in other regions (Sweet and others, 2017). The Alaska coastline has regions with similar morphology to most other U.S. coastlines—for example, volcanic islands of the Aleutians similar to Hawaii, lithified coastal bluffs in Bristol Bay and on the Kenai Peninsula similar to California, sandy barrier islands on the North Slope similar to the Outer Banks of North Carolina, and rocky cliffs in southeast Alaska similar to Maine. Alaska is different, however, in that the coastline is affected by periglacial processes and in many regions composed of permafrost. In general, permafrost is coldest and most continuous along the North Slope and in northwest Alaska, and becomes more discontinuous, with temperatures closer to the freezing point (i.e., 32°F, or 0°C), moving south toward the Yukon–Kuskokwim Delta and Bristol Bay (Jorgenson and others, 2008). Sea ice forms in the Beaufort, Chukchi, and Bering seas each fall and winter. The sea ice extent moves south as air temperatures drop, extending out to the Pribilof Islands in the middle of the Bering Sea and along the coast to Bristol Bay (in some years); the sea

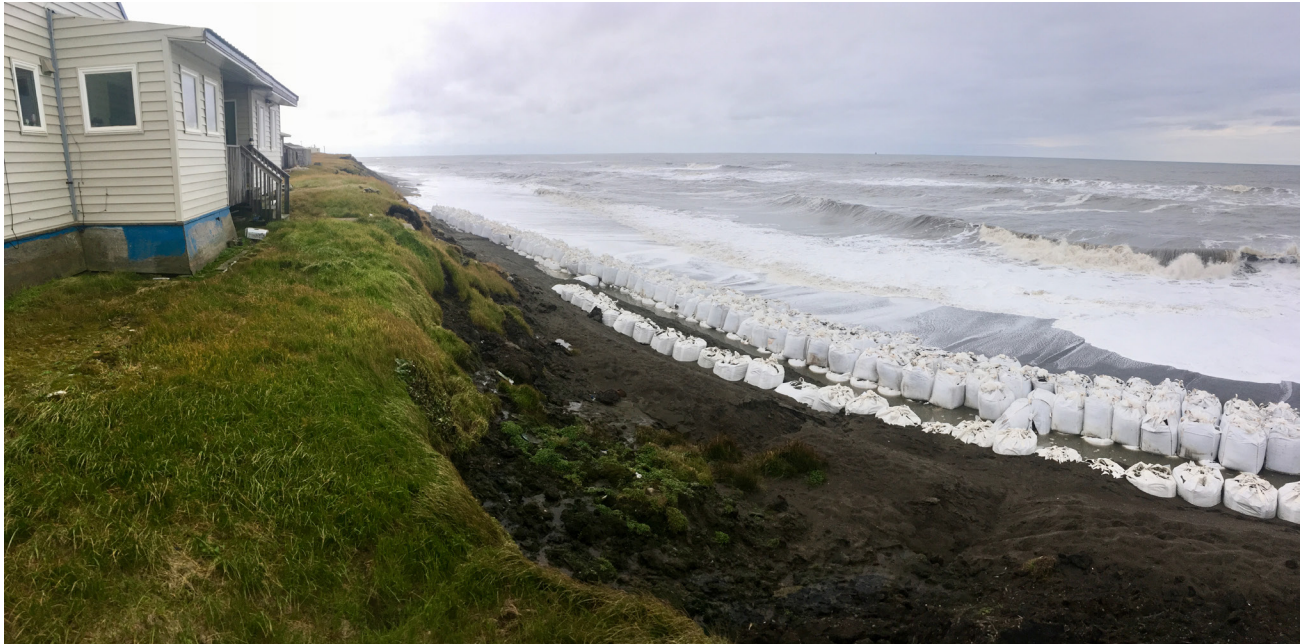
**Figure 6.** Erosion of ice-rich coastal bluffs at Utqiagvik during a coastal storm. Photo taken August 2019. Sandbags have been placed at the base of the coastal bluff to mitigate erosion.

The North Slope Borough actively manages erosion at the North Slope community hub, Utqiagvik, through management of a sand berm that is built up before and during high water and wave events. Although these might be considered

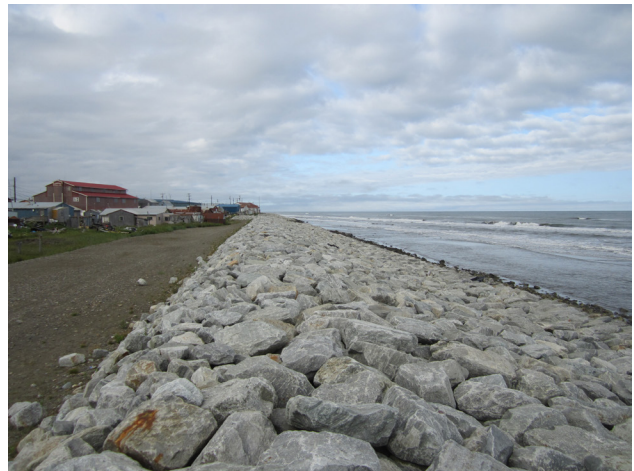
**Figure 8.** Shishmaref rock revetments. Photo taken August 2017.

can effectively reduce the rate of erosion over the section of coast on which they are built. This is the case at Shishmaref, where historical erosion of the barrier island was very rapid. However, in recent years, portions of the island have been protected by multiple rock revetments (fig. 8). Although erosion along the rock revetments was effectively mitigated after construction, these large structures are cost prohibitive; as a result, the revetments do not extend along the entire length of the island, meaning rapid erosion still occurs south of the revetments at the community's airport, landfill, frontage road, and subsistence sites (fig. 9). Hardening the shoreline can also have negative impacts on adjacent areas that may become sediment starved because of the loss of sediment from the previously eroding coastline, or where edge effects result in greater focus of wave energy on the ends of the hardened structure, resulting in erosion on either side of a revetment (Griggs, 2005). Any shoreline revetment built to halt erosion will eventually result in the loss of access to the beach and, over time, the erosion of

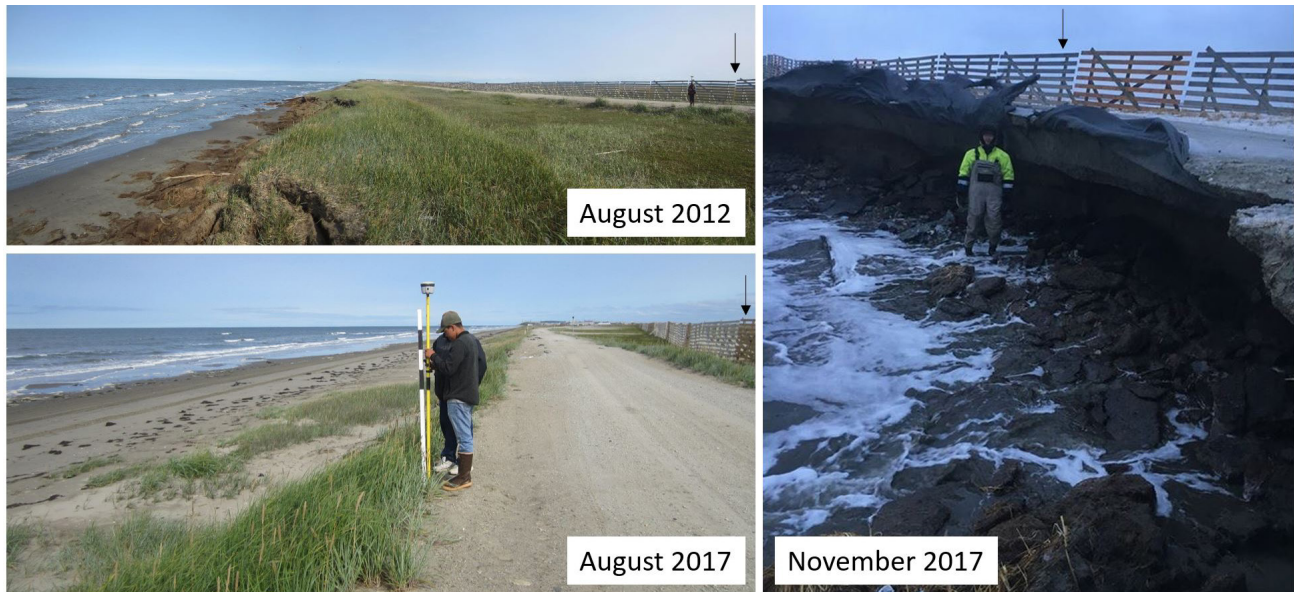
**Figure 9.** Erosion south of the rock revetments at Shishmaref between August 2012 and August 2017, as well as after a storm in November 2017 (photo provided by the Native Village of Shishmaref), with a stationary snow fence for spatial reference.

Rock revetments utilize large boulder-sized rocks, which can be displaced by waves and rock scour during large storm events and thus require investments in maintenance if they are to protect in

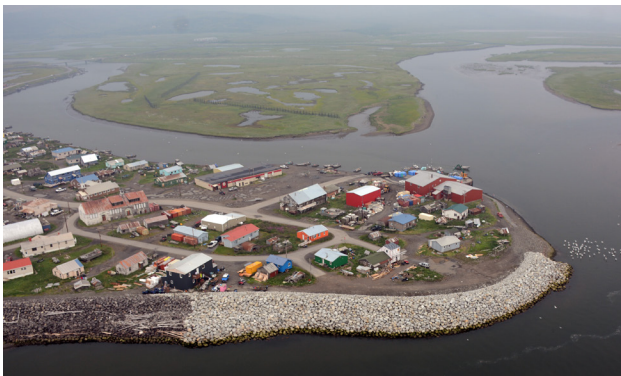
**Figure 10.** Oblique photograph of a portion of the rock revetment at Unalakleet, taken July 2015 (ShoreZone, 2019).

the long term. Rock revetments or rubble mounds were placed at Kivalina, Unalakleet, and St. Michael to mitigate erosion (figs. 7, 10, 11). The community of Deering is located on a sand spit in Kotzebue Sound, and for the most part is fronted by an interlocking concrete revetment. In recent years, however, the revetment has been undermined by coastal storm activity (fig. 12). Without investments to maintain and repair infrastructure, such rock revetments, rubble mounds, and concrete revetments eventually become at risk to erosion again.

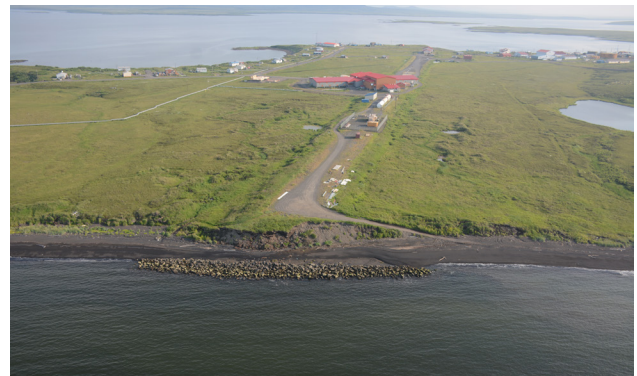
**Figure 11.** Oblique photograph of rock mound at St. Michael, taken July 2015 (ShoreZone, 2019).

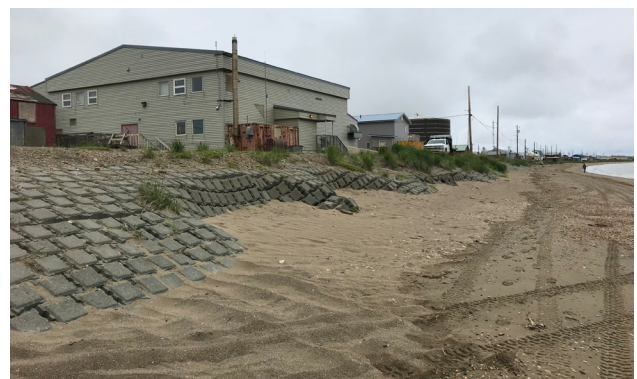
**Figure 12.** Erosion control structure at Deering, which was undermined and damaged by storm surges. Photo taken July 2018.

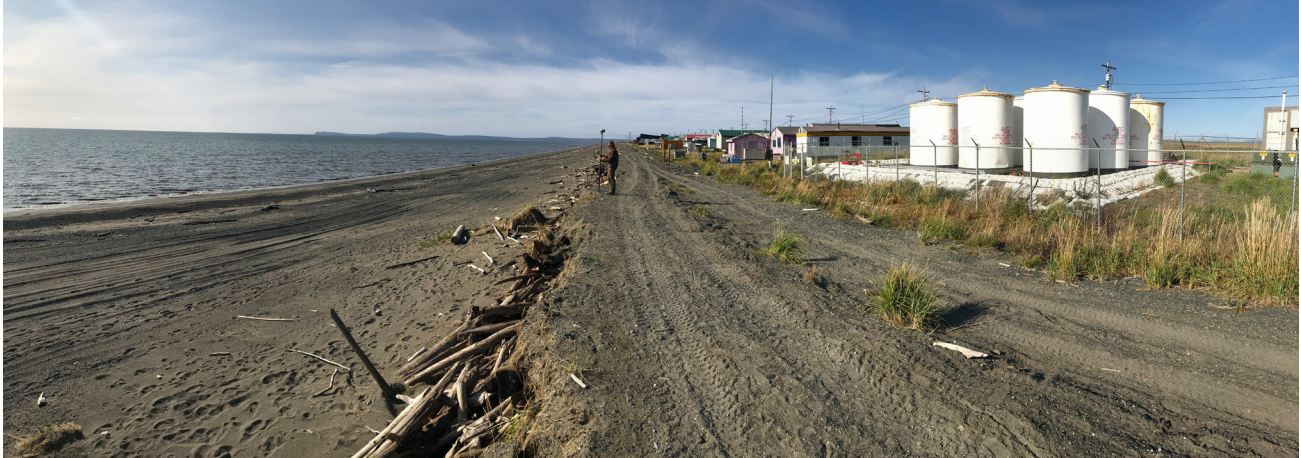
**Figure 13.** Unconsolidated gravel berm (used as a road) in front of the tank farm in Shaktoolik. Photo taken after a storm in August 2019 eroded the berm.

The community of Shaktoolik is located on a mixed sand-gravel spit at the head of Norton Sound. In 2015, the community began construction of an unconsolidated gravel berm because of its low cost compared to that of a rock revetment; however, gravel is more easily eroded. A storm in August 2019 impacted both Shaktoolik and nearby Unalakleet, causing no damage in Unalakleet but significantly eroding Shaktoolik's gravel berm (fig. 13).

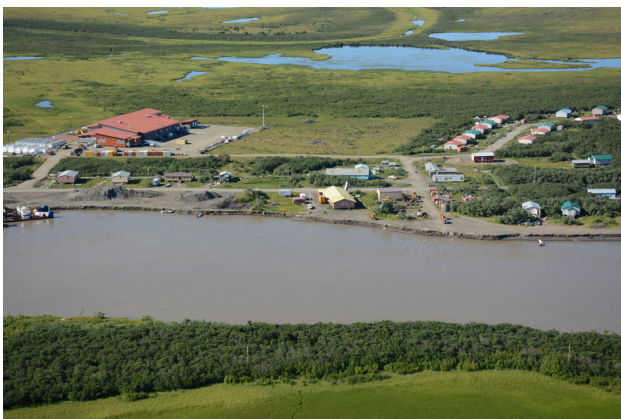
**Figure 14.** River bank at Alakanuk, where erosion has already undermined a road and other infrastructure. Photo taken August 2014 (ShoreZone, 2019).

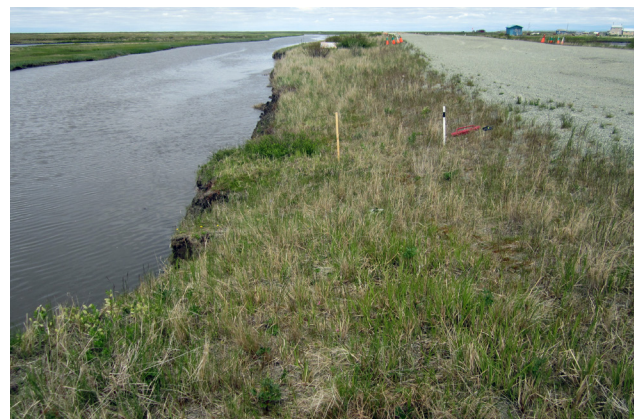
**Figure 15.** Erosion near the airstrip at Kwigillingok, which is also susceptible to permafrost degradation and flooding, which may lead to usteq. Photo taken June 2017.

soils makes this region of Alaska particularly vulnerable to the combined impacts of flooding, erosion, and permafrost degradation. “Usteq” is the Yup’ik term for land collapse that involves the complex interactions of flooding, erosion, and permafrost degradation, which when combined can be disastrous (DHSEM, 2018). Usteq at the community of Kwigillingok has resulted in vast environmental changes across the landscape of the community. The combination of floods and thawing permafrost has resulted in lakes draining and rerouting across the community and near infrastructure, changing entire drainage systems. Due to the complex nature of these changes, the effects from usteq at Kwigillingok were not easily tracked through the shoreline change analysis conducted as part of this report.

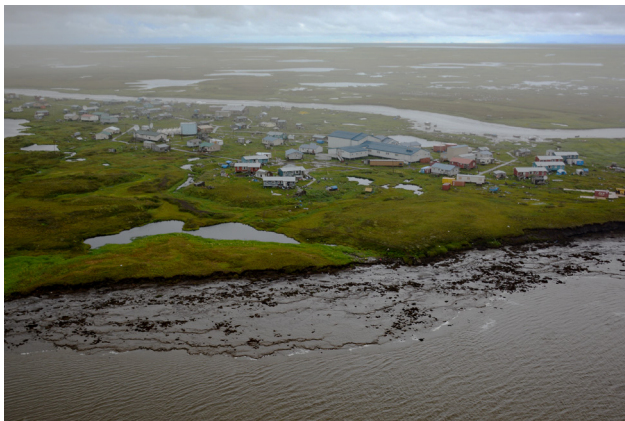
**Figure 16.** Oblique photograph of Newtok taken August 2014 (ShoreZone, 2019). Since then, erosion has begun to undermine the residential buildings nearest the river bank.

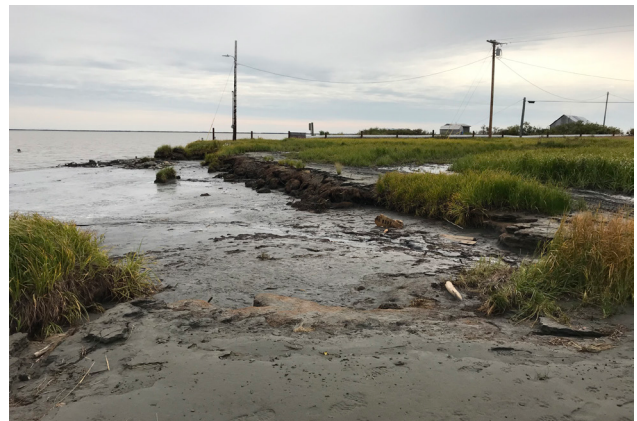
**Figure 17.** Erosion at Nunam Iqua near power poles and community water source intake pipe. Photo taken August 2019.

The Yukon–Kuskokwim Delta has the highest population density of northern and western Alaska (Department of Labor and Workforce Development [DLWD], 2010). Many residences and critical facilities are at risk to imminent erosion; however, very few erosion control structures have been constructed to mitigate erosion to date. Limited construction could be due to lack of available rock in the region. The most successful strategy has been to move structures one building at a time through local efforts (e.g., Native Village of Kwigillingok and URS Corporation, 2015). Local capacity to move structures can be dependent on access to heavy equipment, as well as on funds for fuel and skilled labor. Consequently, most of these deltaic communities are now more at risk than the communities that remain higher up on statewide rankings (UAF and others, 2019), such as those that have had rock revetments built since their original assessment. For example, Nunam Iqua is relocating, abandoning, and demolishing coastal infrastructure in response to the encroaching shoreline ( $6.9 \pm 1.3$  ft per year [ $2.1 \pm 0.4$  m per year]; fig. 17). These erosion impacts were noted but not

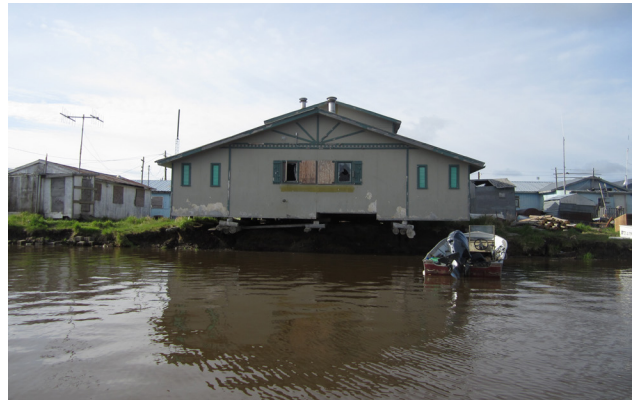
**Figure 18.** Building overhanging river bank at Kotlik. Photo taken June 2017. Concrete blocks from dilapidated NRCS erosion-control structure piled along river bank.

At communities where mitigation structures have been built, very limited investments have been made to maintain them. For example, in the 1980s, a concrete interlocking block revetment was installed at the community of Kotlik on the Yukon River. Though the structure reduced erosion rates, it is now in disrepair and beyond its original lifespan. The river banks are currently eroding, and some structures are now overhanging the river (fig. 18). Similarly, the community of Tununak is located on a mixed sand-gravel spit on Nelson Island, where

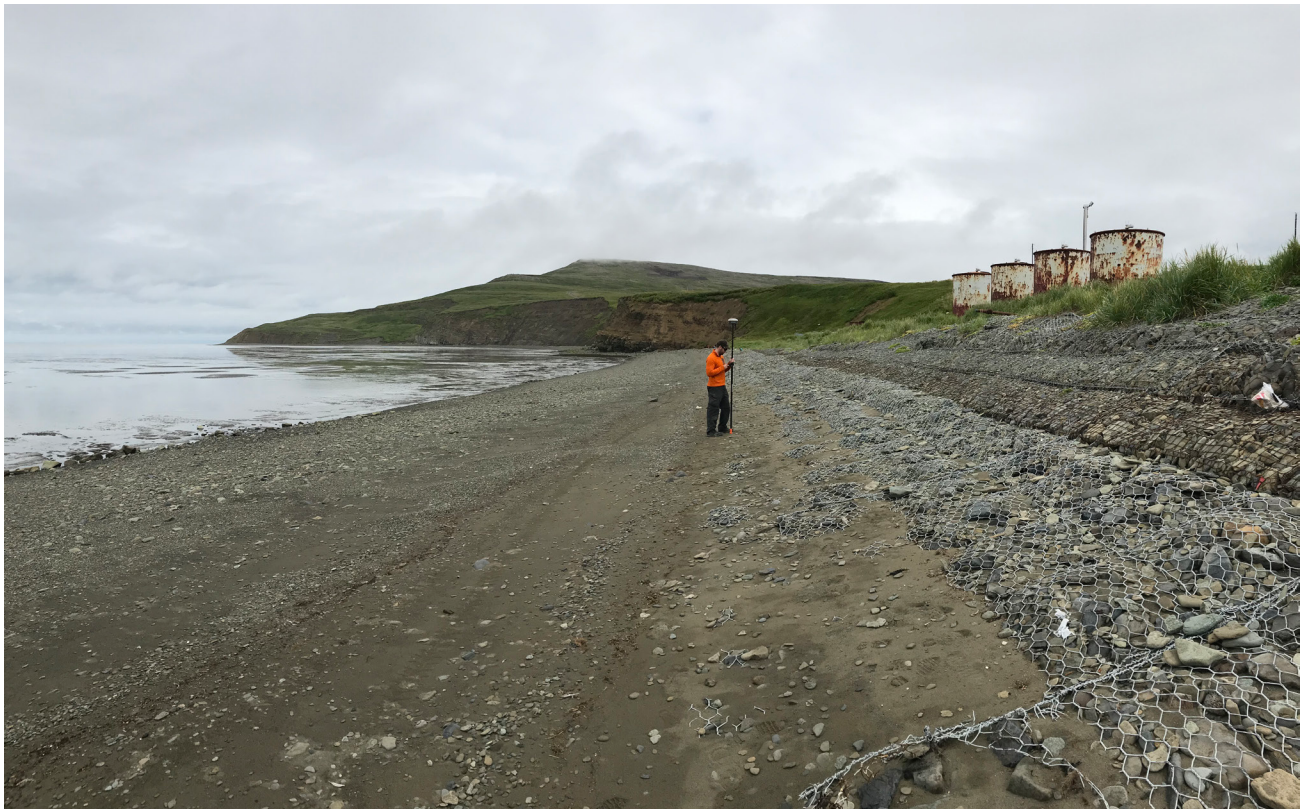
**Figure 19.** Gabion basket revetment at Tununak, August 2019.

erosion is mitigated by a gabion basket revetment along the entire spit, but sections are in need of repair after significant storm damage (fig. 19).

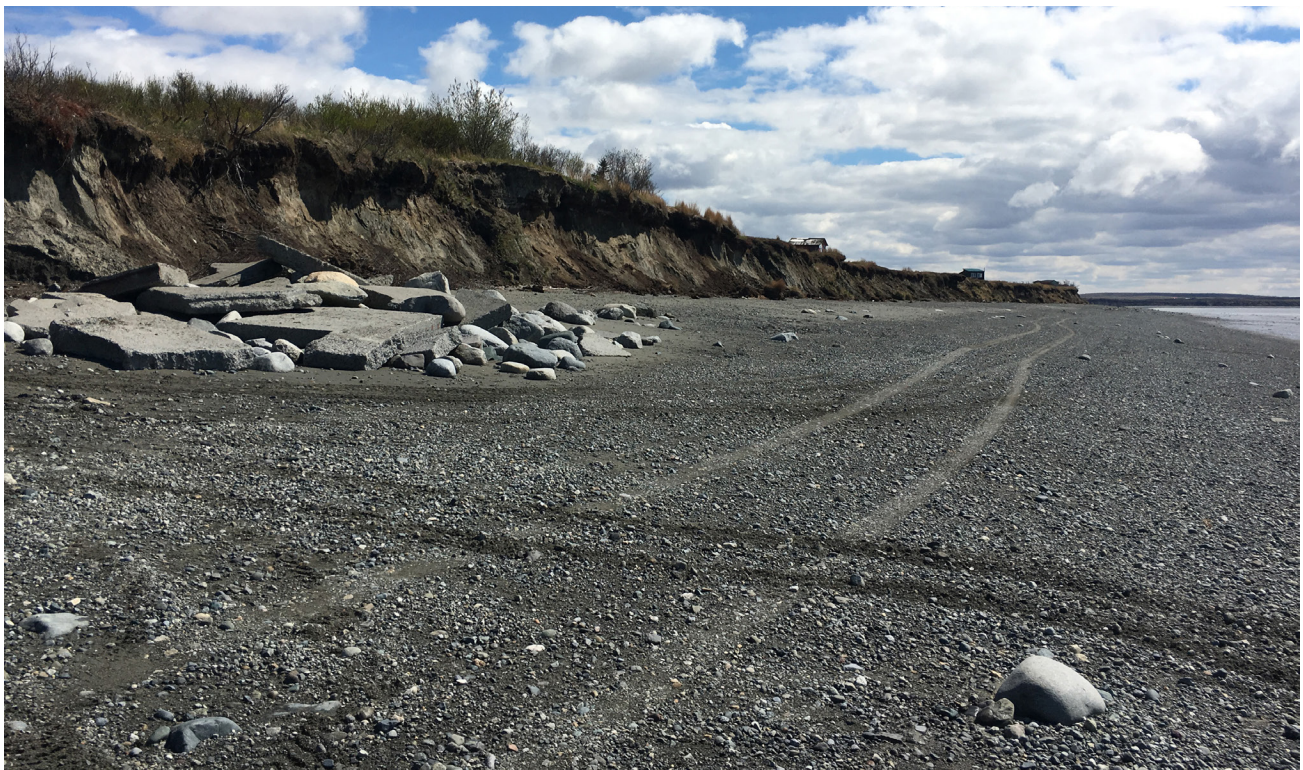
**Figure 20.** Erosion of coastal bluffs at Naknek. Photo taken May 2017.

Most communities in Bristol Bay are perched on tall (>20-ft-high) coastal bluffs as a result of the large tide range (macrotidal; fig. 20) and/or their proximity to river mouths. Bristol Bay communities are commonly centered around commercial salmon fishing sites and fish canneries that were first established in the early 1900s (Wright and others, 1985). Although Jorgenson and others (2008) show no permafrost in Bristol Bay, recent geotechnical surveys presented at the 2019 Alaska Forum on the Environment showed permafrost underlying a wastewater treatment facility in Naknek. Additional research is needed to understand where permafrost is around Bristol Bay and how permafrost might influence erosion. The tall and exposed nature of the bluffs makes them vulnerable to groundwater seepage, overland runoff, and slumping. Coastal bluffs are fronted by mixed sand-gravel beaches, but the bluffs themselves are primarily composed of consolidated and/or clay-rich materials that are more resistant to wave impacts, compared to sandy beaches. During

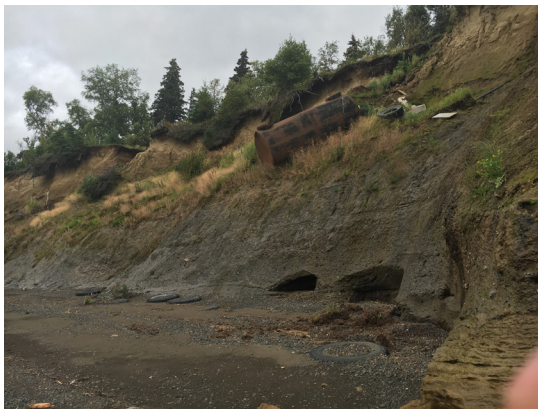
**Figure 21.** Coastal bluffs at Dillingham. Photos taken August 2016.

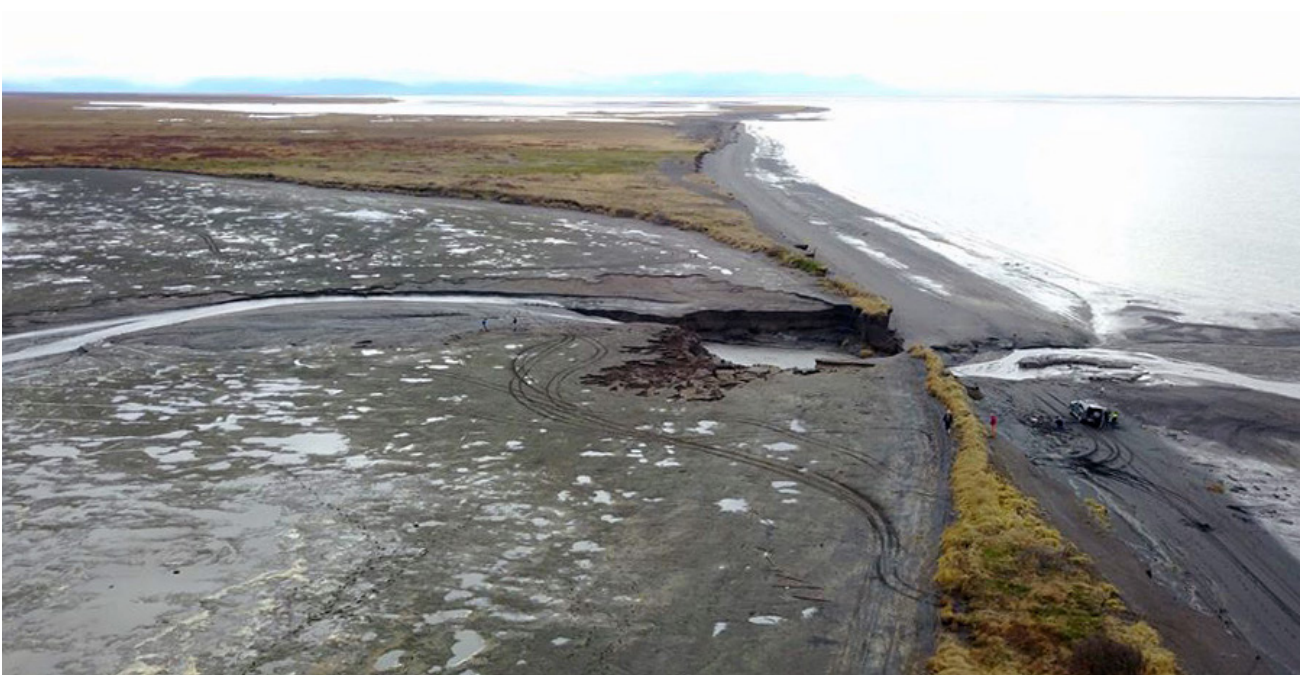
**Figure 22.** Erosion and subsequent drainage of Goldfish Lake at Port Heiden. Photo taken November 2019 by the Native Village of Port Heiden.
