## EROSION EXPOSURE ASSESSMENT—PORT HEIDEN

Report of Investigation 2021-3 Port Heiden

State of Alaska  
Department of Natural Resources  
Division of Geological & Geophysical Surveys

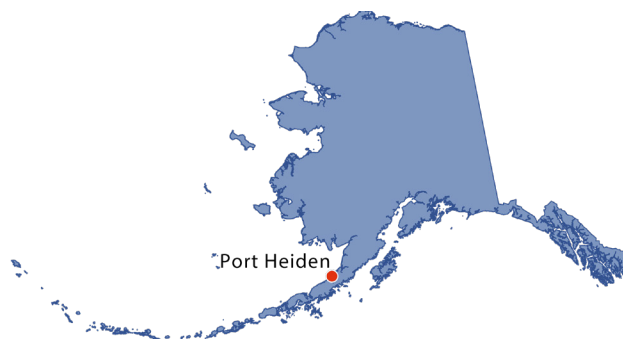
distance from the nearest barge landing pole and the 2039 shoreline to 500 ft. There is one abandoned structure exposed to erosion by 2059. It is possible that erosion will slow if sediment continues to fill in near the barge landing, which also complicates barge operations and navigability. For this reason, we list the barge landing as requiring replacement by 2039. The forecast shows continued undermining of the road to Meshik, which is used for subsistence activities, with up to 1,400 ft exposed in 40 years. The forecast shows erosion of small trail systems on the coast northwest of the community but does not reach the main road to Reindeer Creek by 2059. The total replacement cost of infrastructure exposed to erosion is \$3.06 million ( $\pm$  \$0.92 million) by 2059

(table 2; fig. 1). We do not estimate erosion exposure for water lines because the data are not readily available and no visible water line infrastructure exists in the forecast area. There may be abandoned underground pipes and septic systems that do not have a replacement cost but will require cleanup when they are uncovered by erosion.

**Figure 1.** This figure shows the replacement cost of utilities, transportation infrastructure, and buildings and tank facilities that are forecast to erode per 20-year interval. Twenty-year intervals are symbolized by color: purple represents the time interval 2019 to 2039 and orange represents 2039 to 2059. The bulk of costs are the barge landing in the first 20 years (purple).
